## EXISTING CONDITIONS REFERENCE INFORMATION

### Summary of Port of Albany Field Investigation:

# Fendering Photos

Project name:Port of Albany Wharf

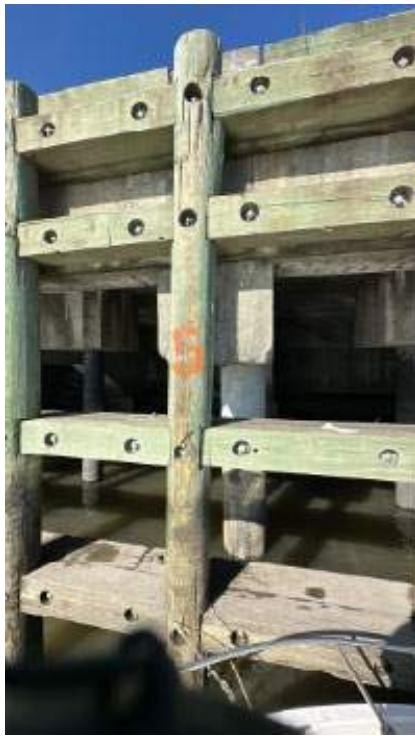
| Media 7: Bent 5, minor spalling at both corners. | | |

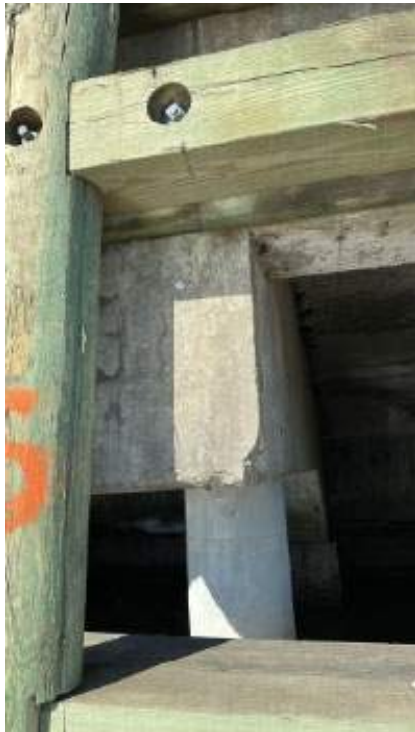
| Media 8: Bent 5, minor spalling at both corners. | | |

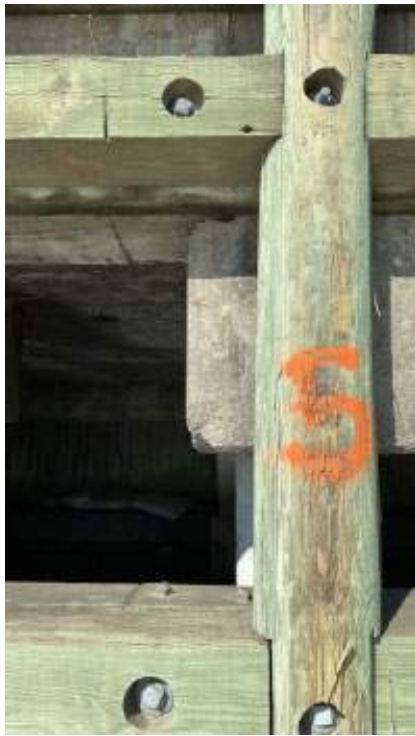
| Media 9: Bent 5, minor spalling at both corners. | | |

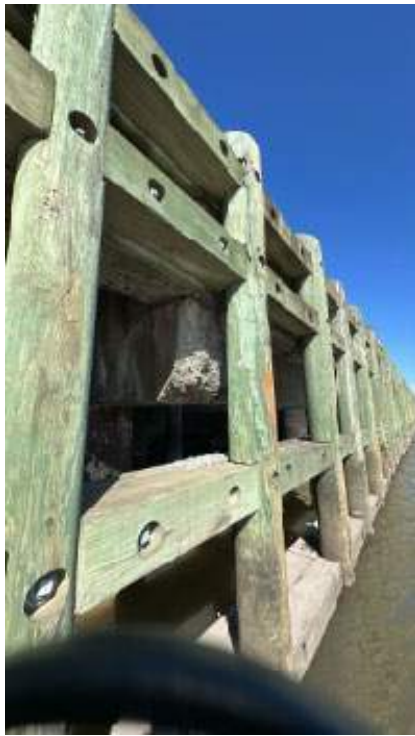
| Media 27: Bent 12. Significant damage to face. Exposed rebar. | | |

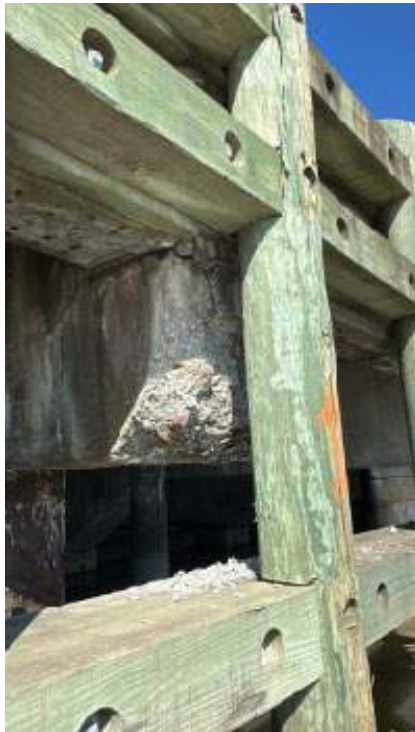
| Media 28: Bent 12. Significant damage to face. Exposed rebar. | | |

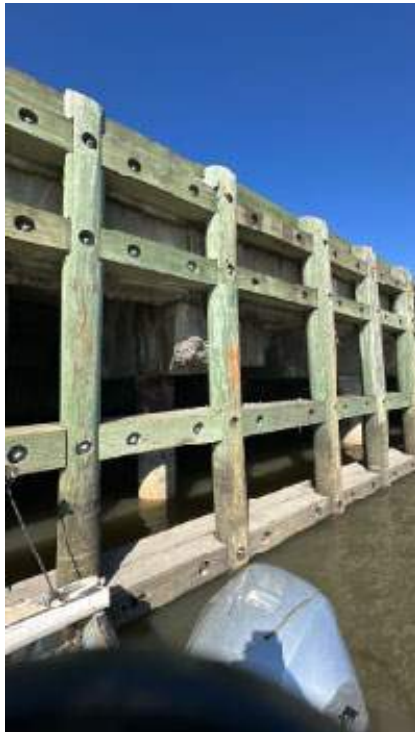
Media 30: Bent 12. Significant damage to face. Exposed rebar.

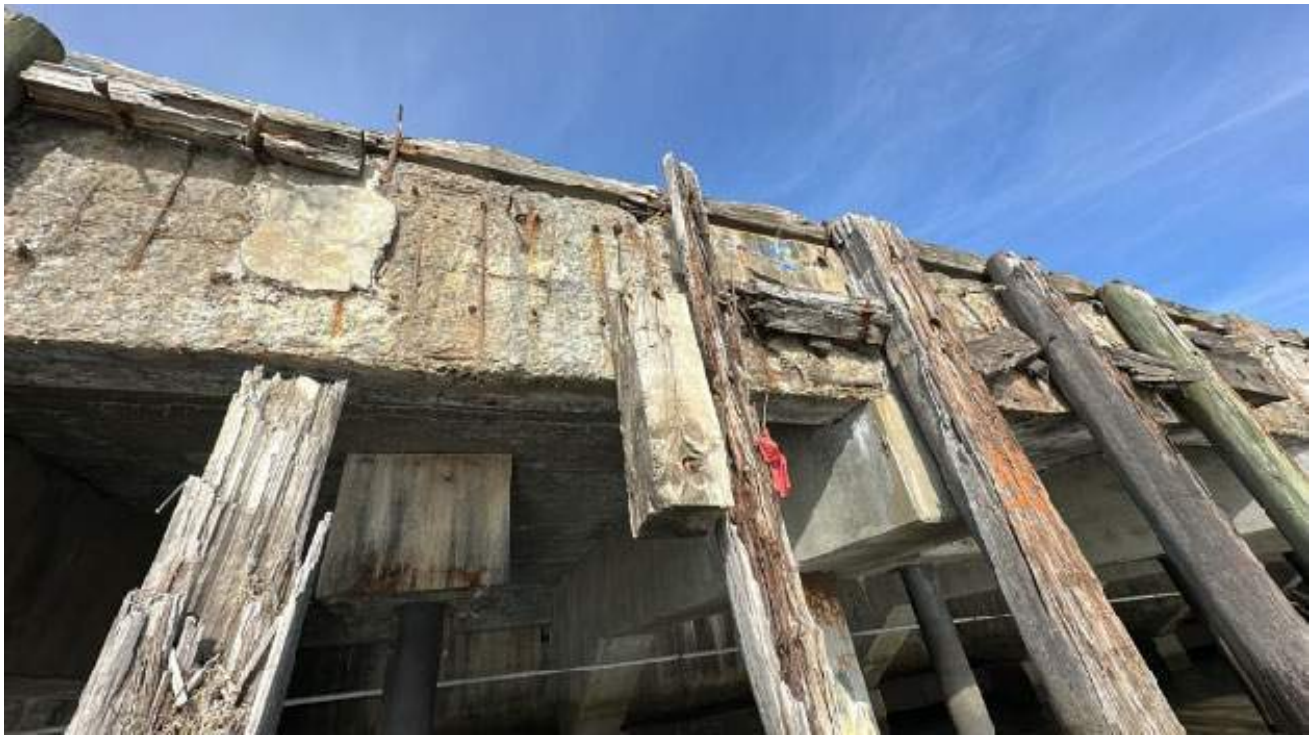
Media 223: Complete loss of cover between fence 38 and 39 on fascia beam.

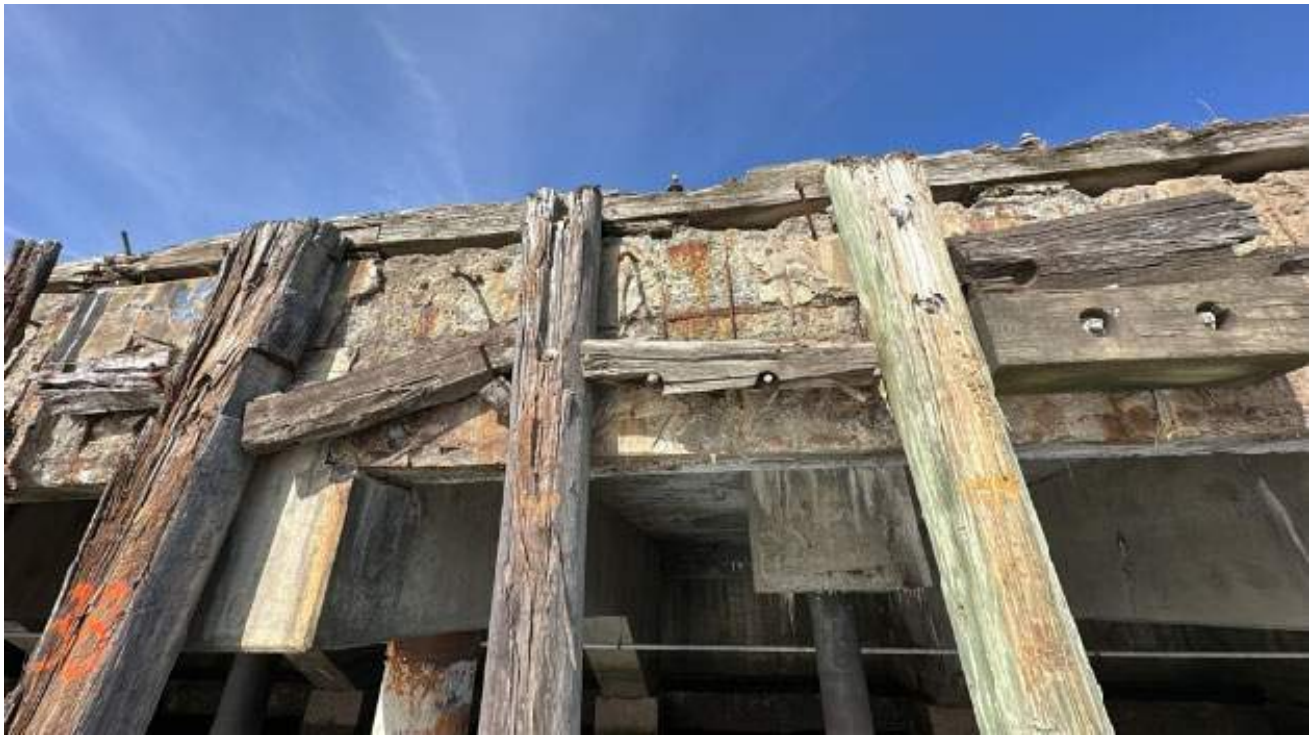
Media 225: Cover on a fascia beam between bent 39 and bent 40 missing.

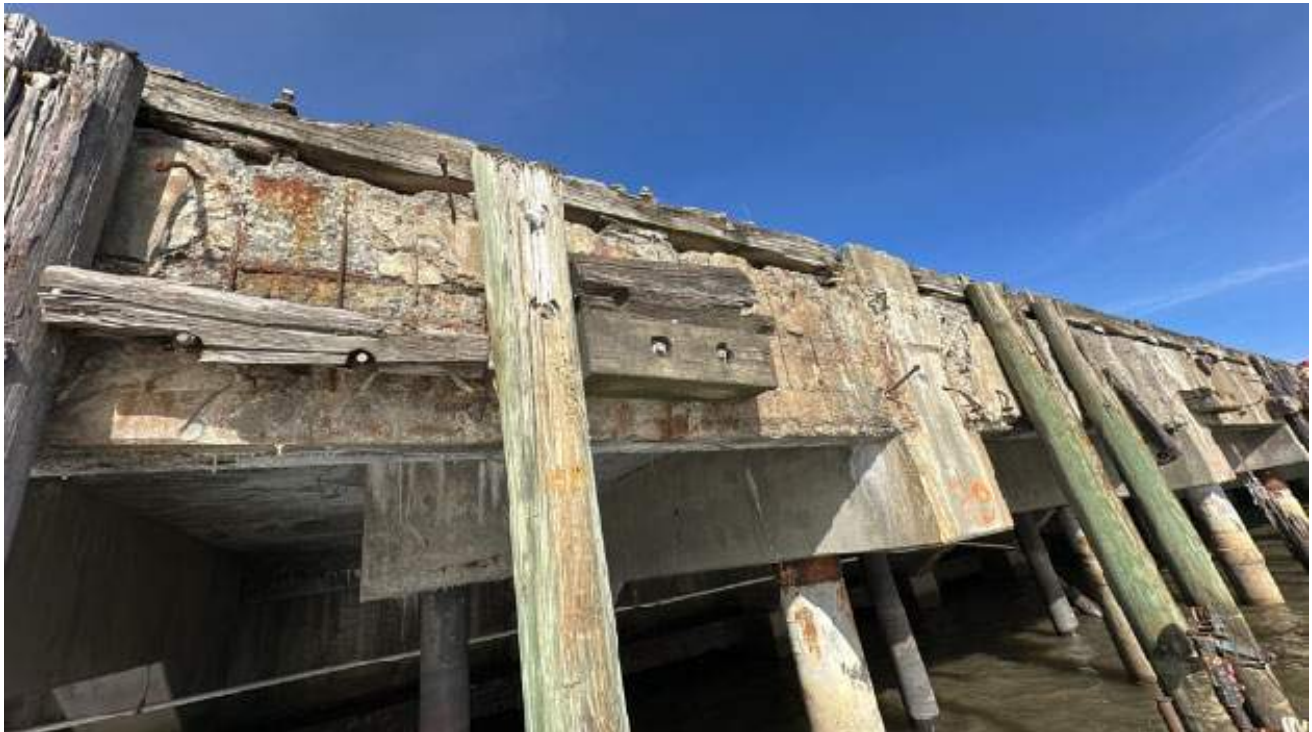
Media 226: Cover on a fascia beam between bent 39 and bent 40 missing.

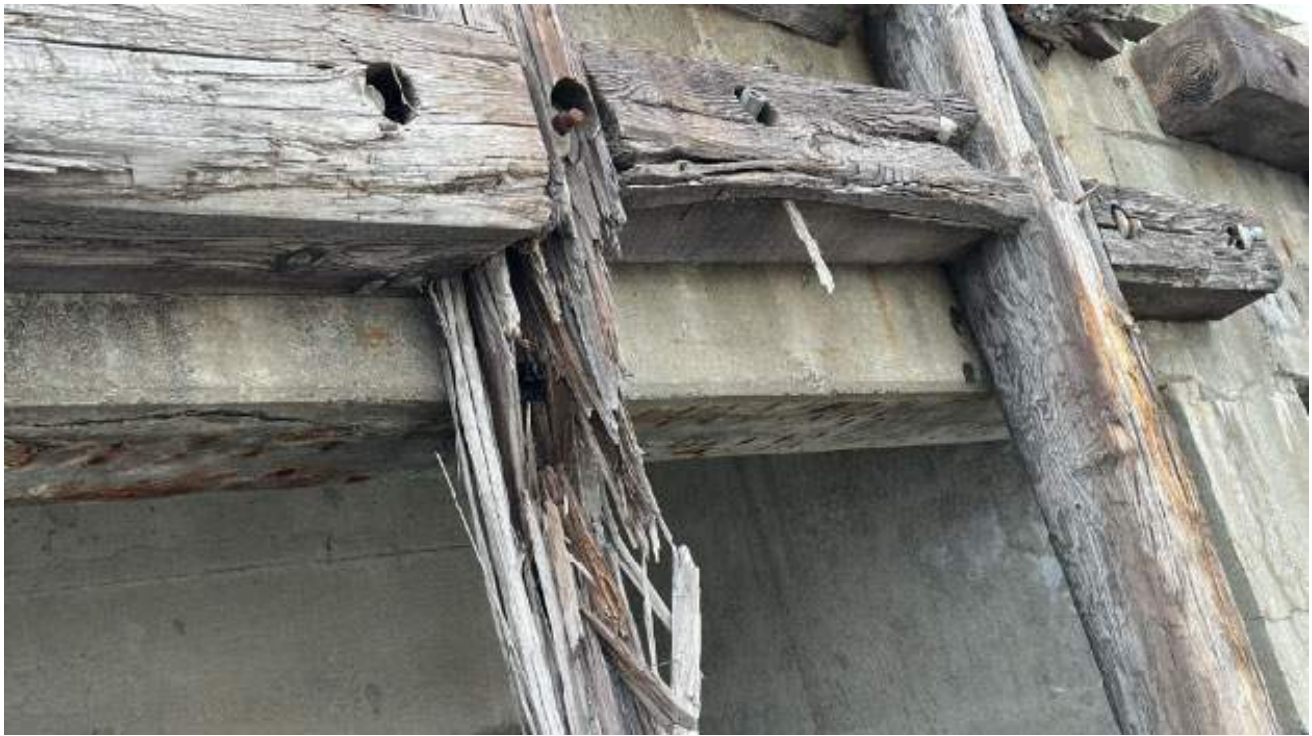
Media 227: Crack on fascia beam between bents 54 and 55

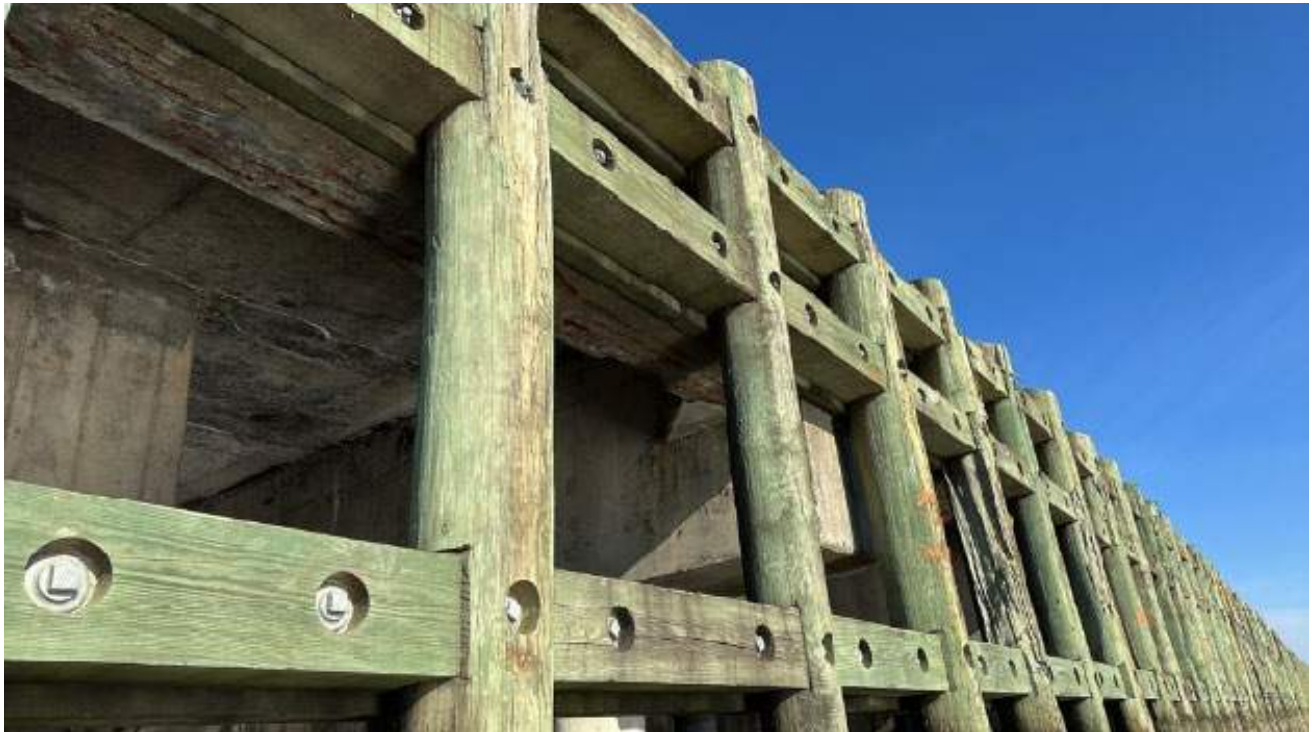
Media 228: Cracked on fascia beam by Bent 3.

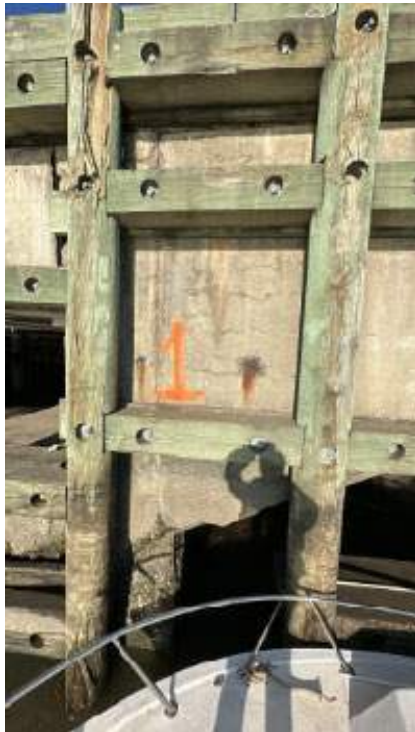
Media 230: Damage at bottom of bent one.

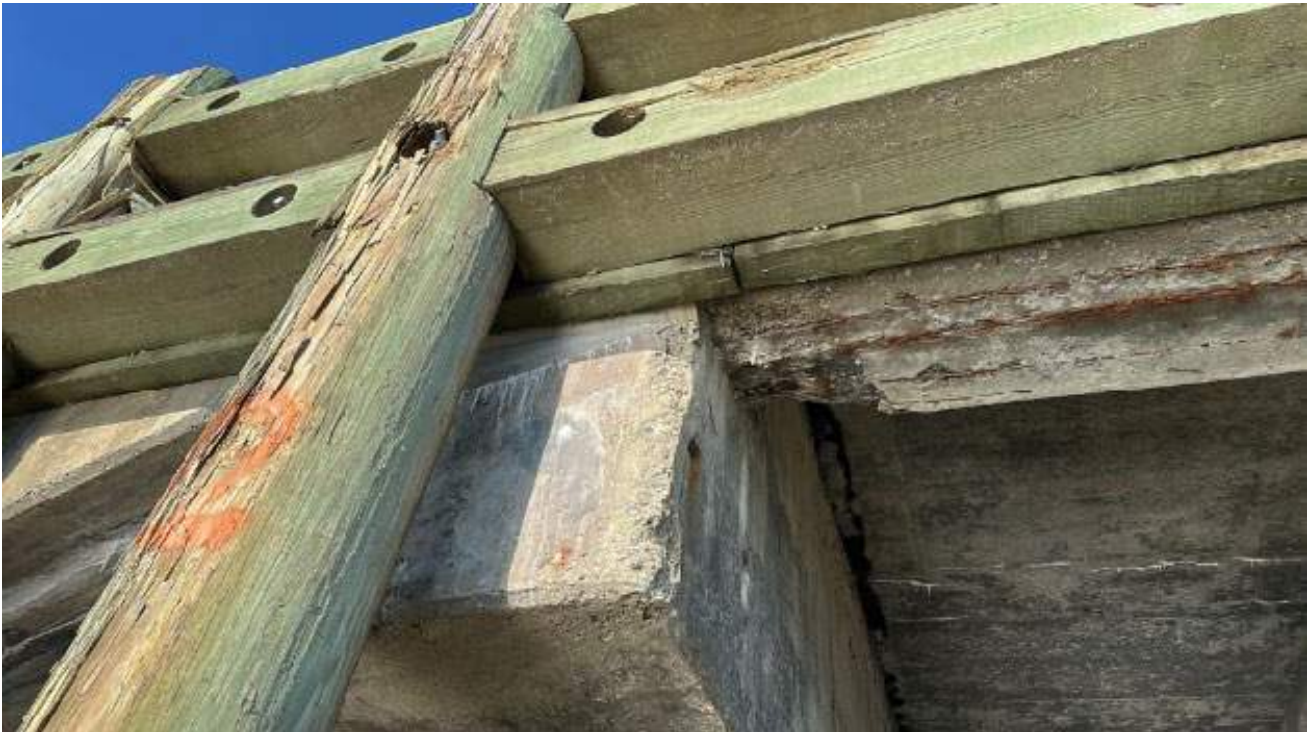
Media 232: Damage on fascia beam near bent two.

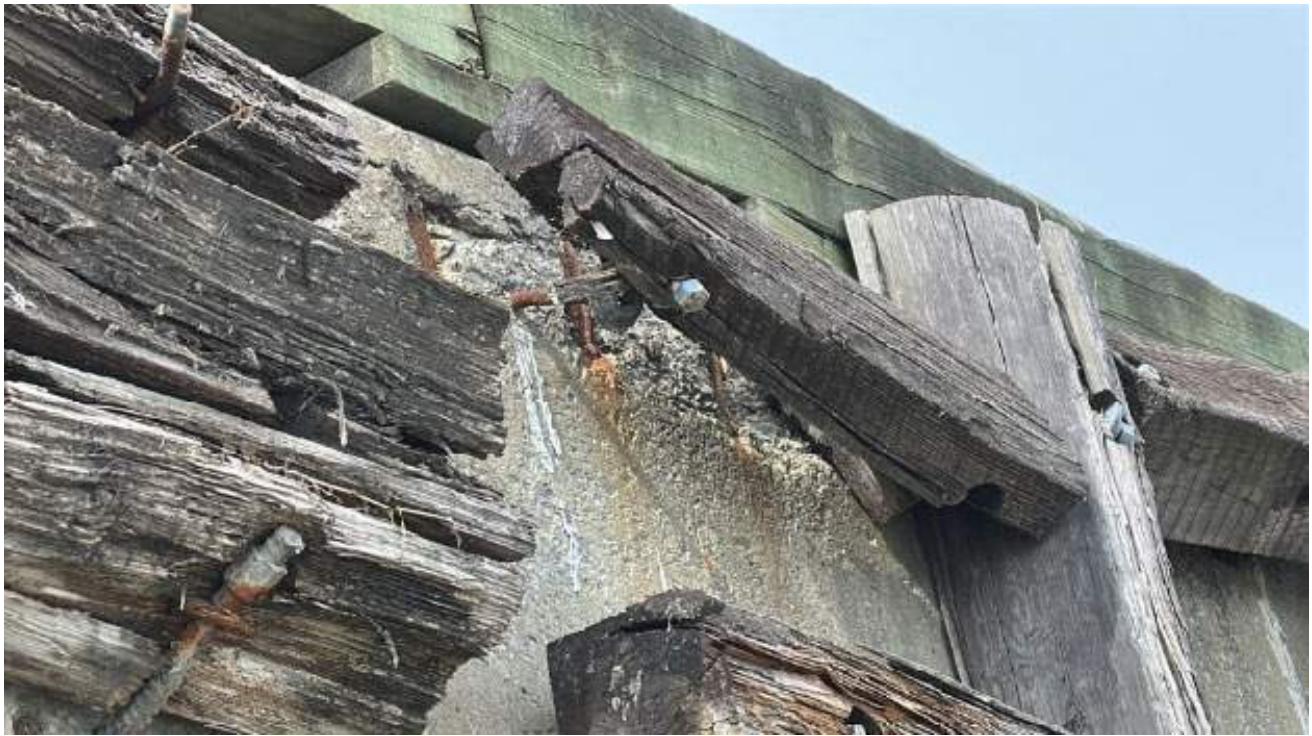
Media 237: Exposed rebar on fascia beam between bent 52 and 53

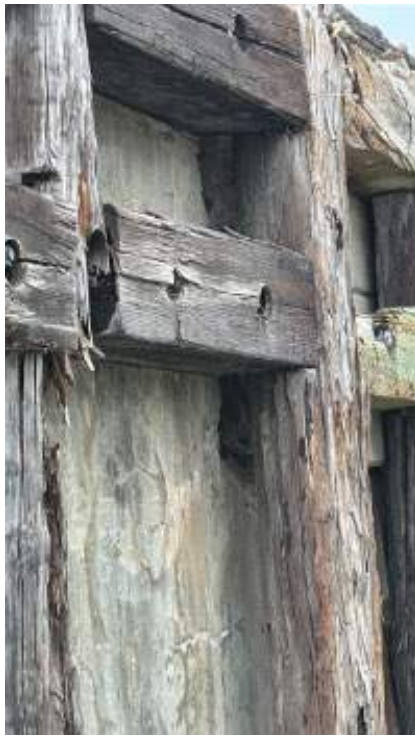
| Media 239: Large crack behind Bent 58 | | |

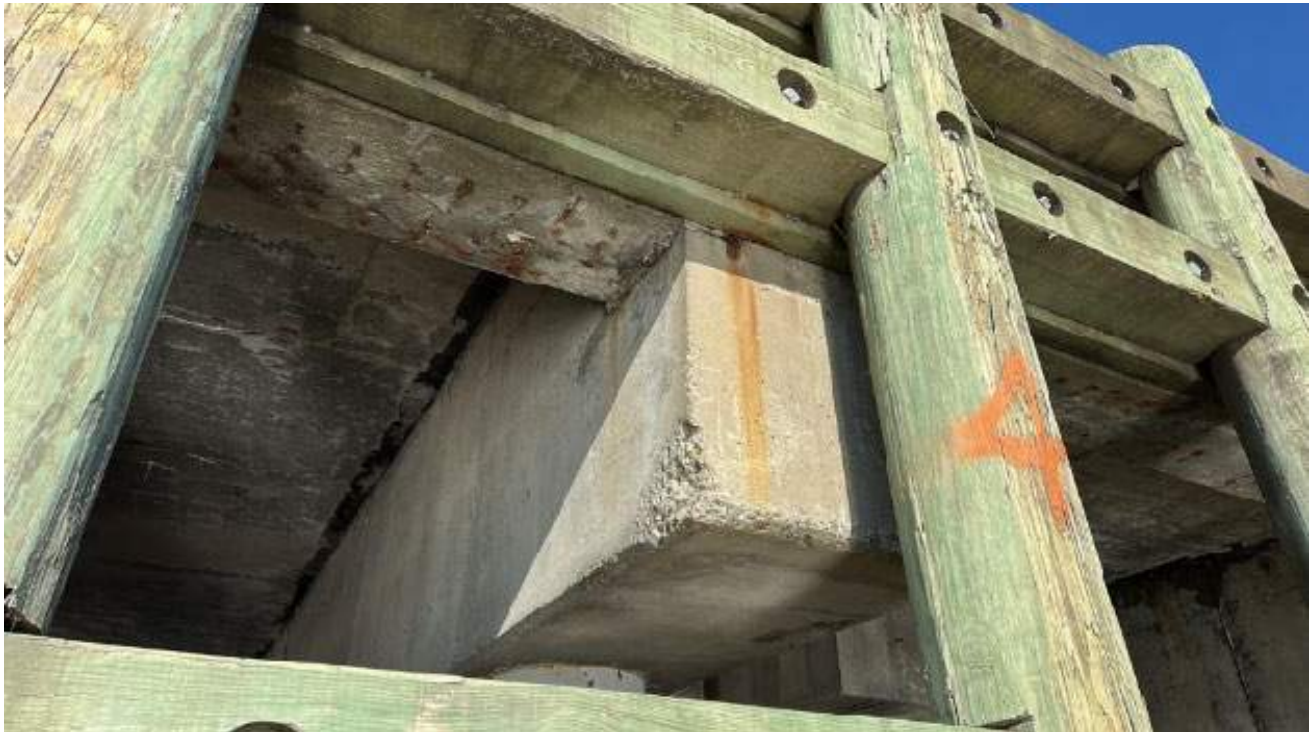
| Media 240: Minor falling on Bend 4. | | |
