**LANDFILL CLOSURE CERTIFICATION REPORT  
NYSDEC REGISTRATION No. 01L12211**

**PORT OF ALBANY EXPANSION PROJECT  
BEACON ISLAND PARCEL  
BETHLEHEM, ALBANY COUNTY, NEW YORK**

**ATL REPORT No. AT5596CE-32-11-24**

**November 4, 2024**

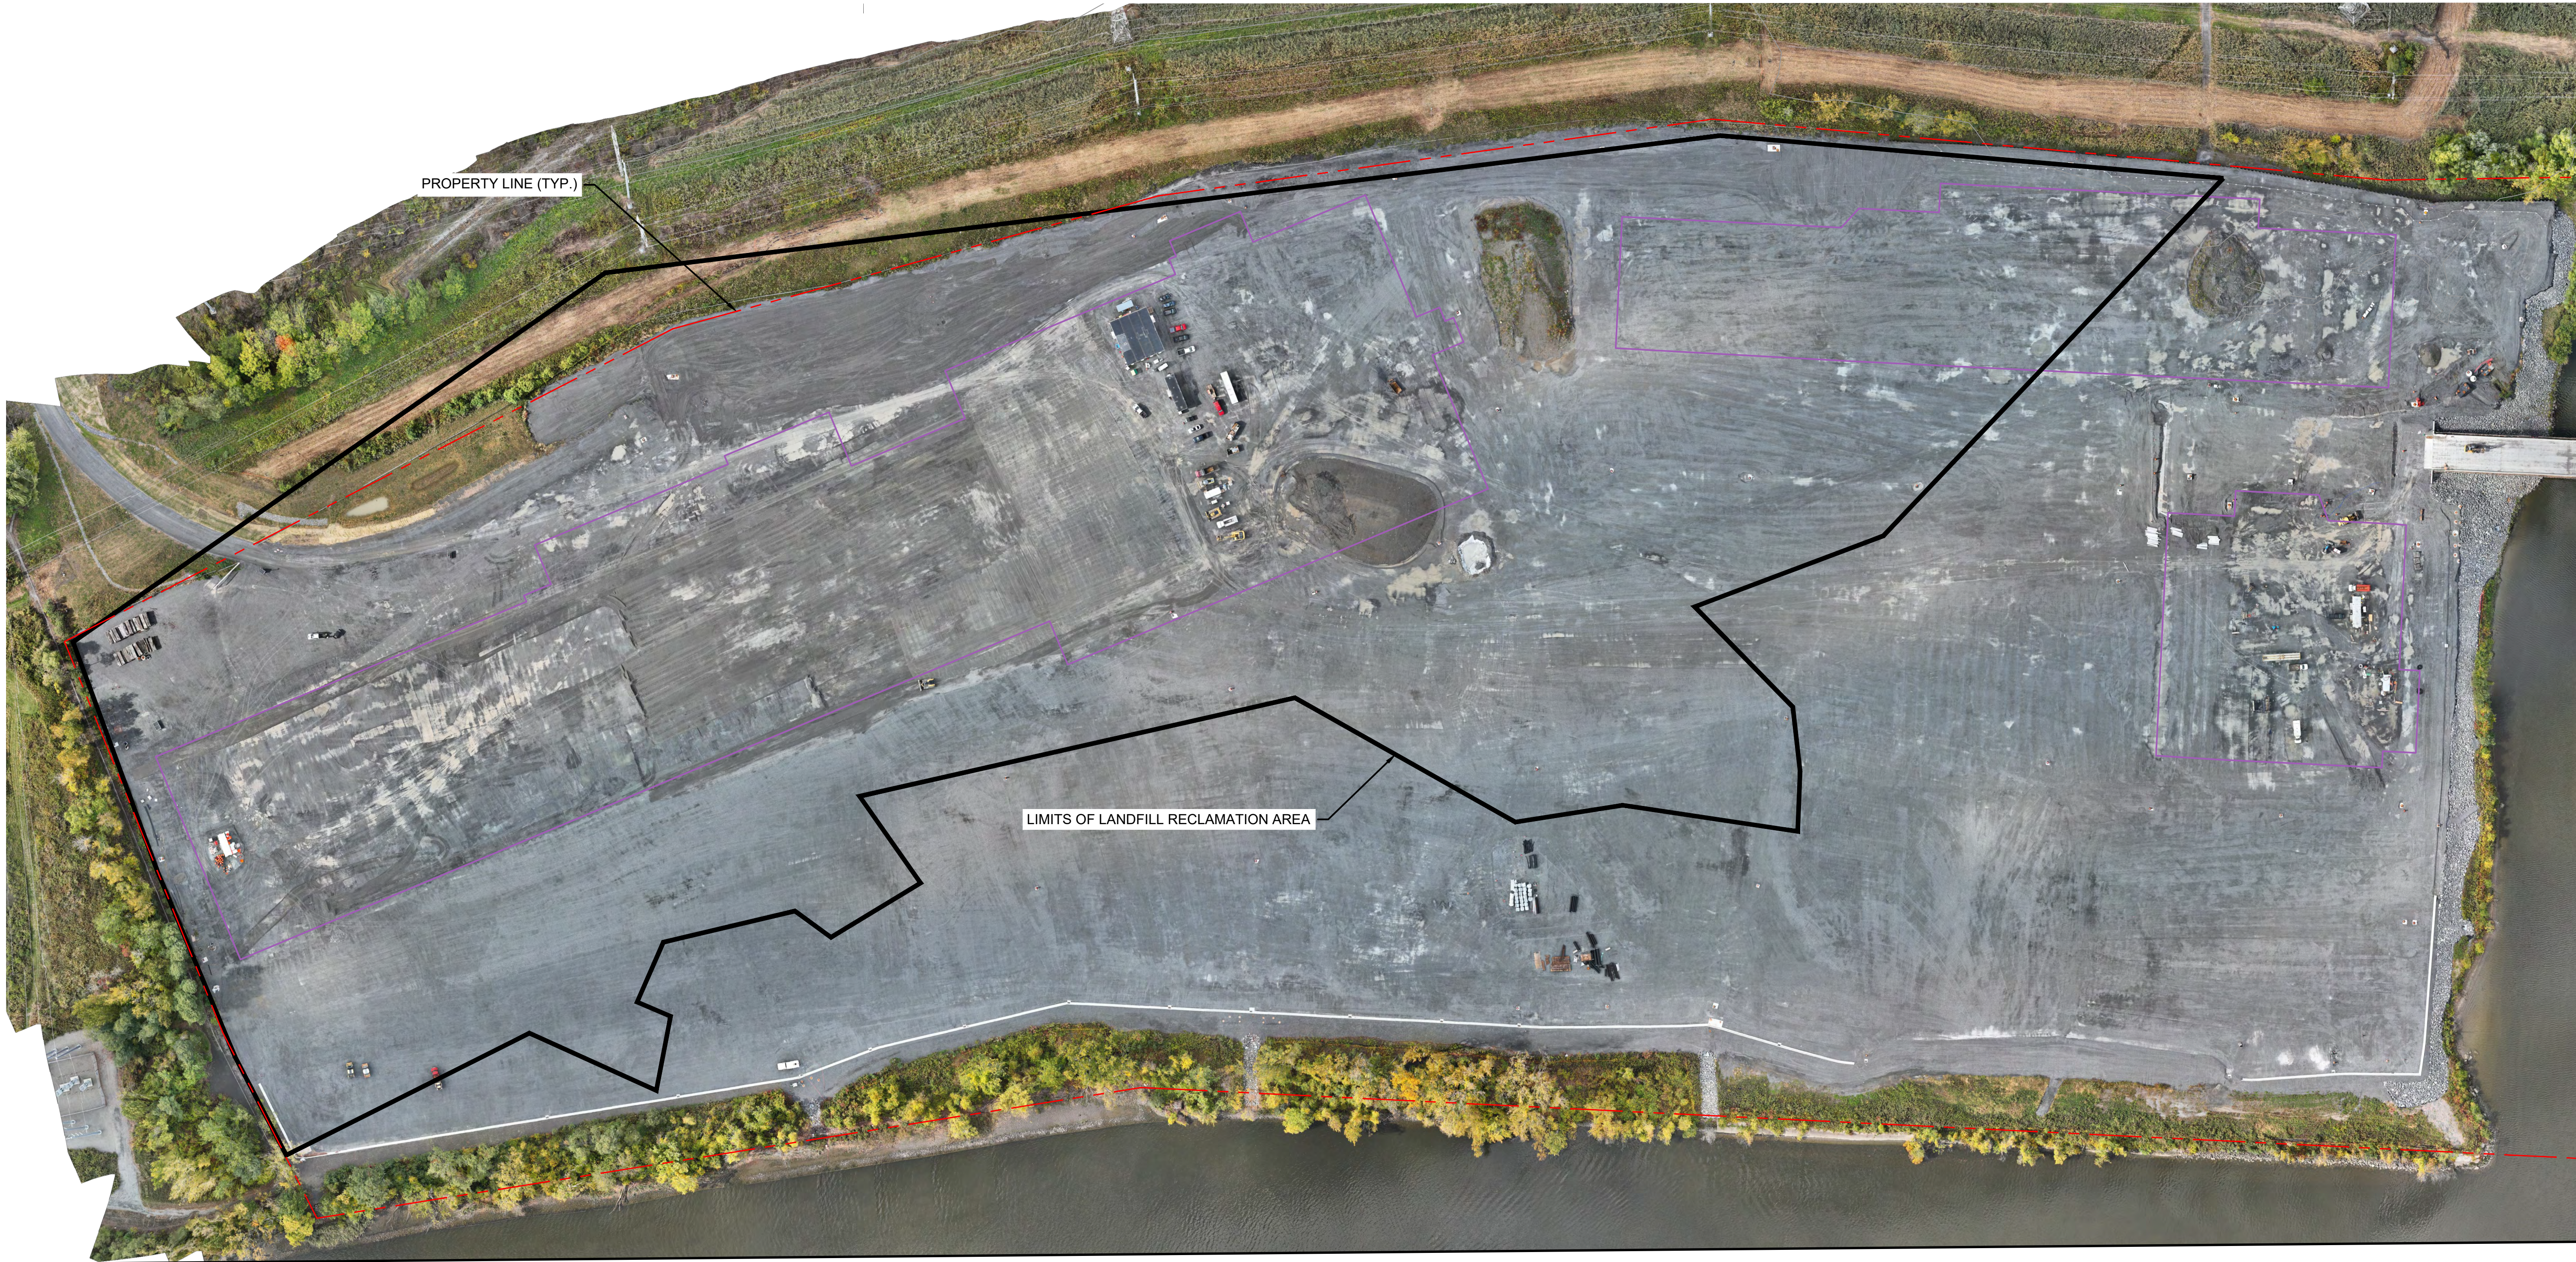
DRAWING NUMBER  
**FIGURE 2**

AERIAL SITE PHOTO FROM OCTOBER 15, 2024.

A Site Location Map, showing the location of the subject site, is attached as **Figure 1**. A Landfill Reclamation Aerial Photo (Photograph Dated October 15, 2024) is provided as **Figure 2**.

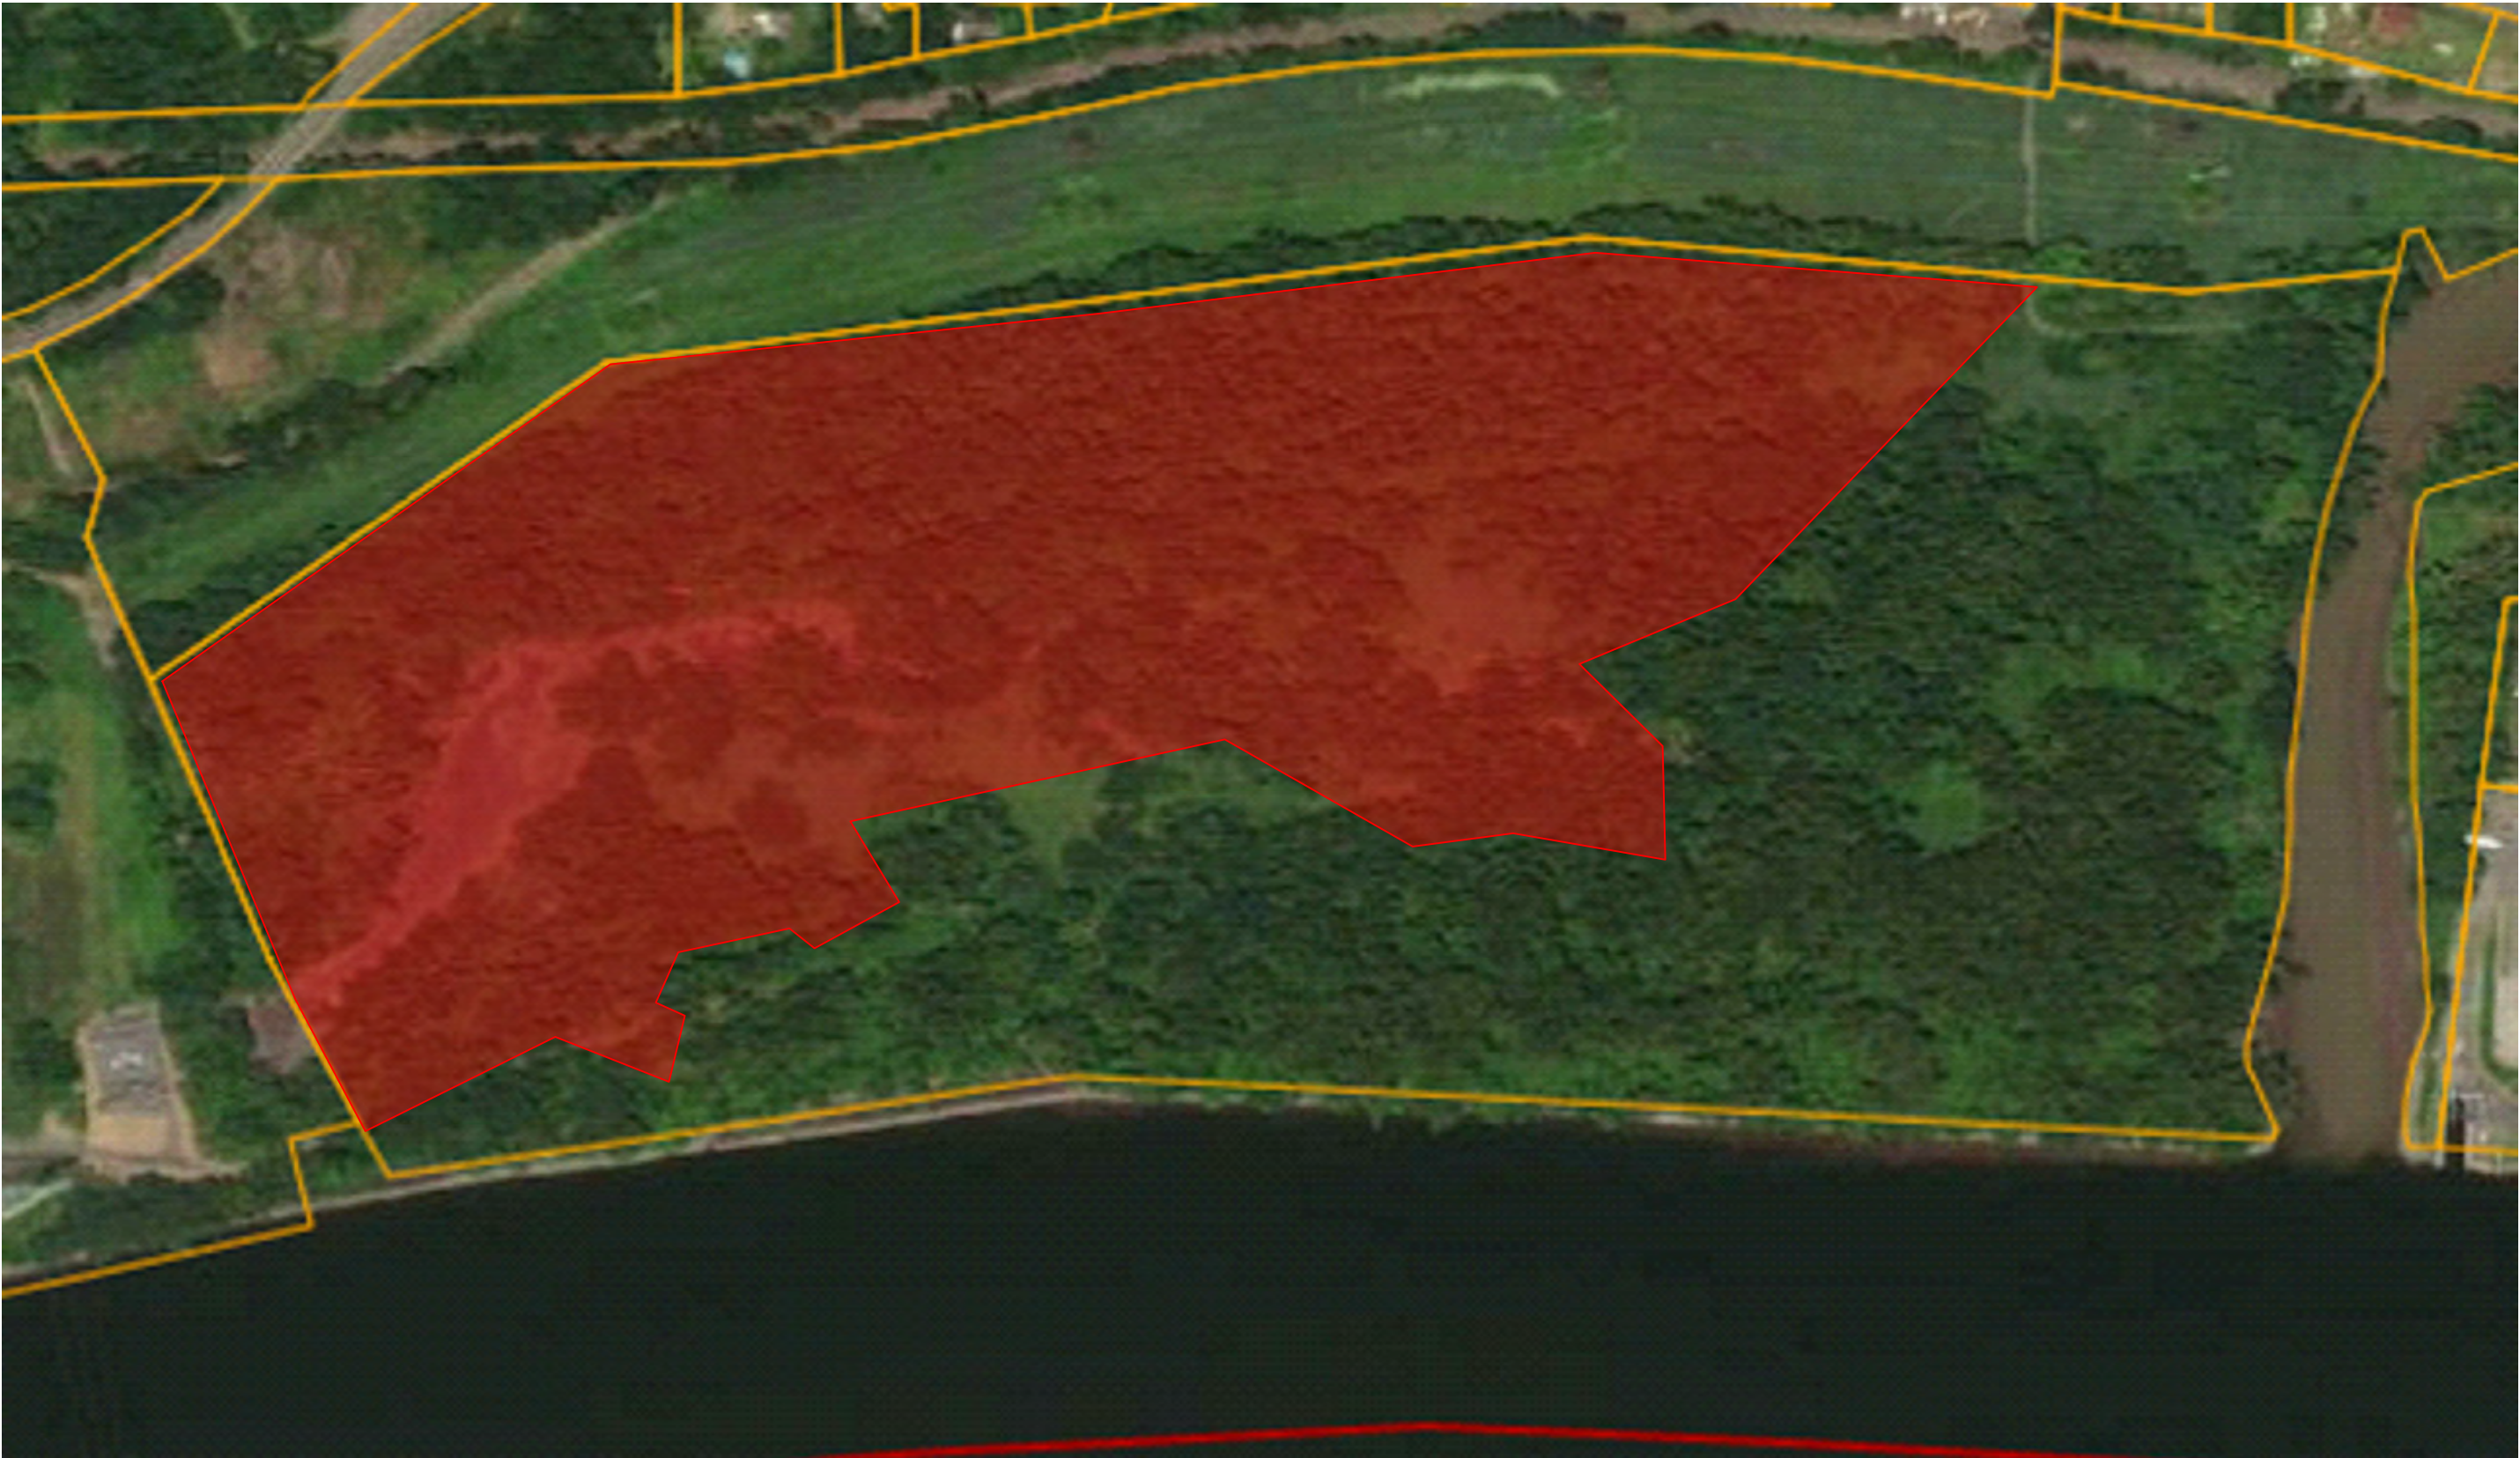
Approximate Aerial Extents of Coal Ash Material

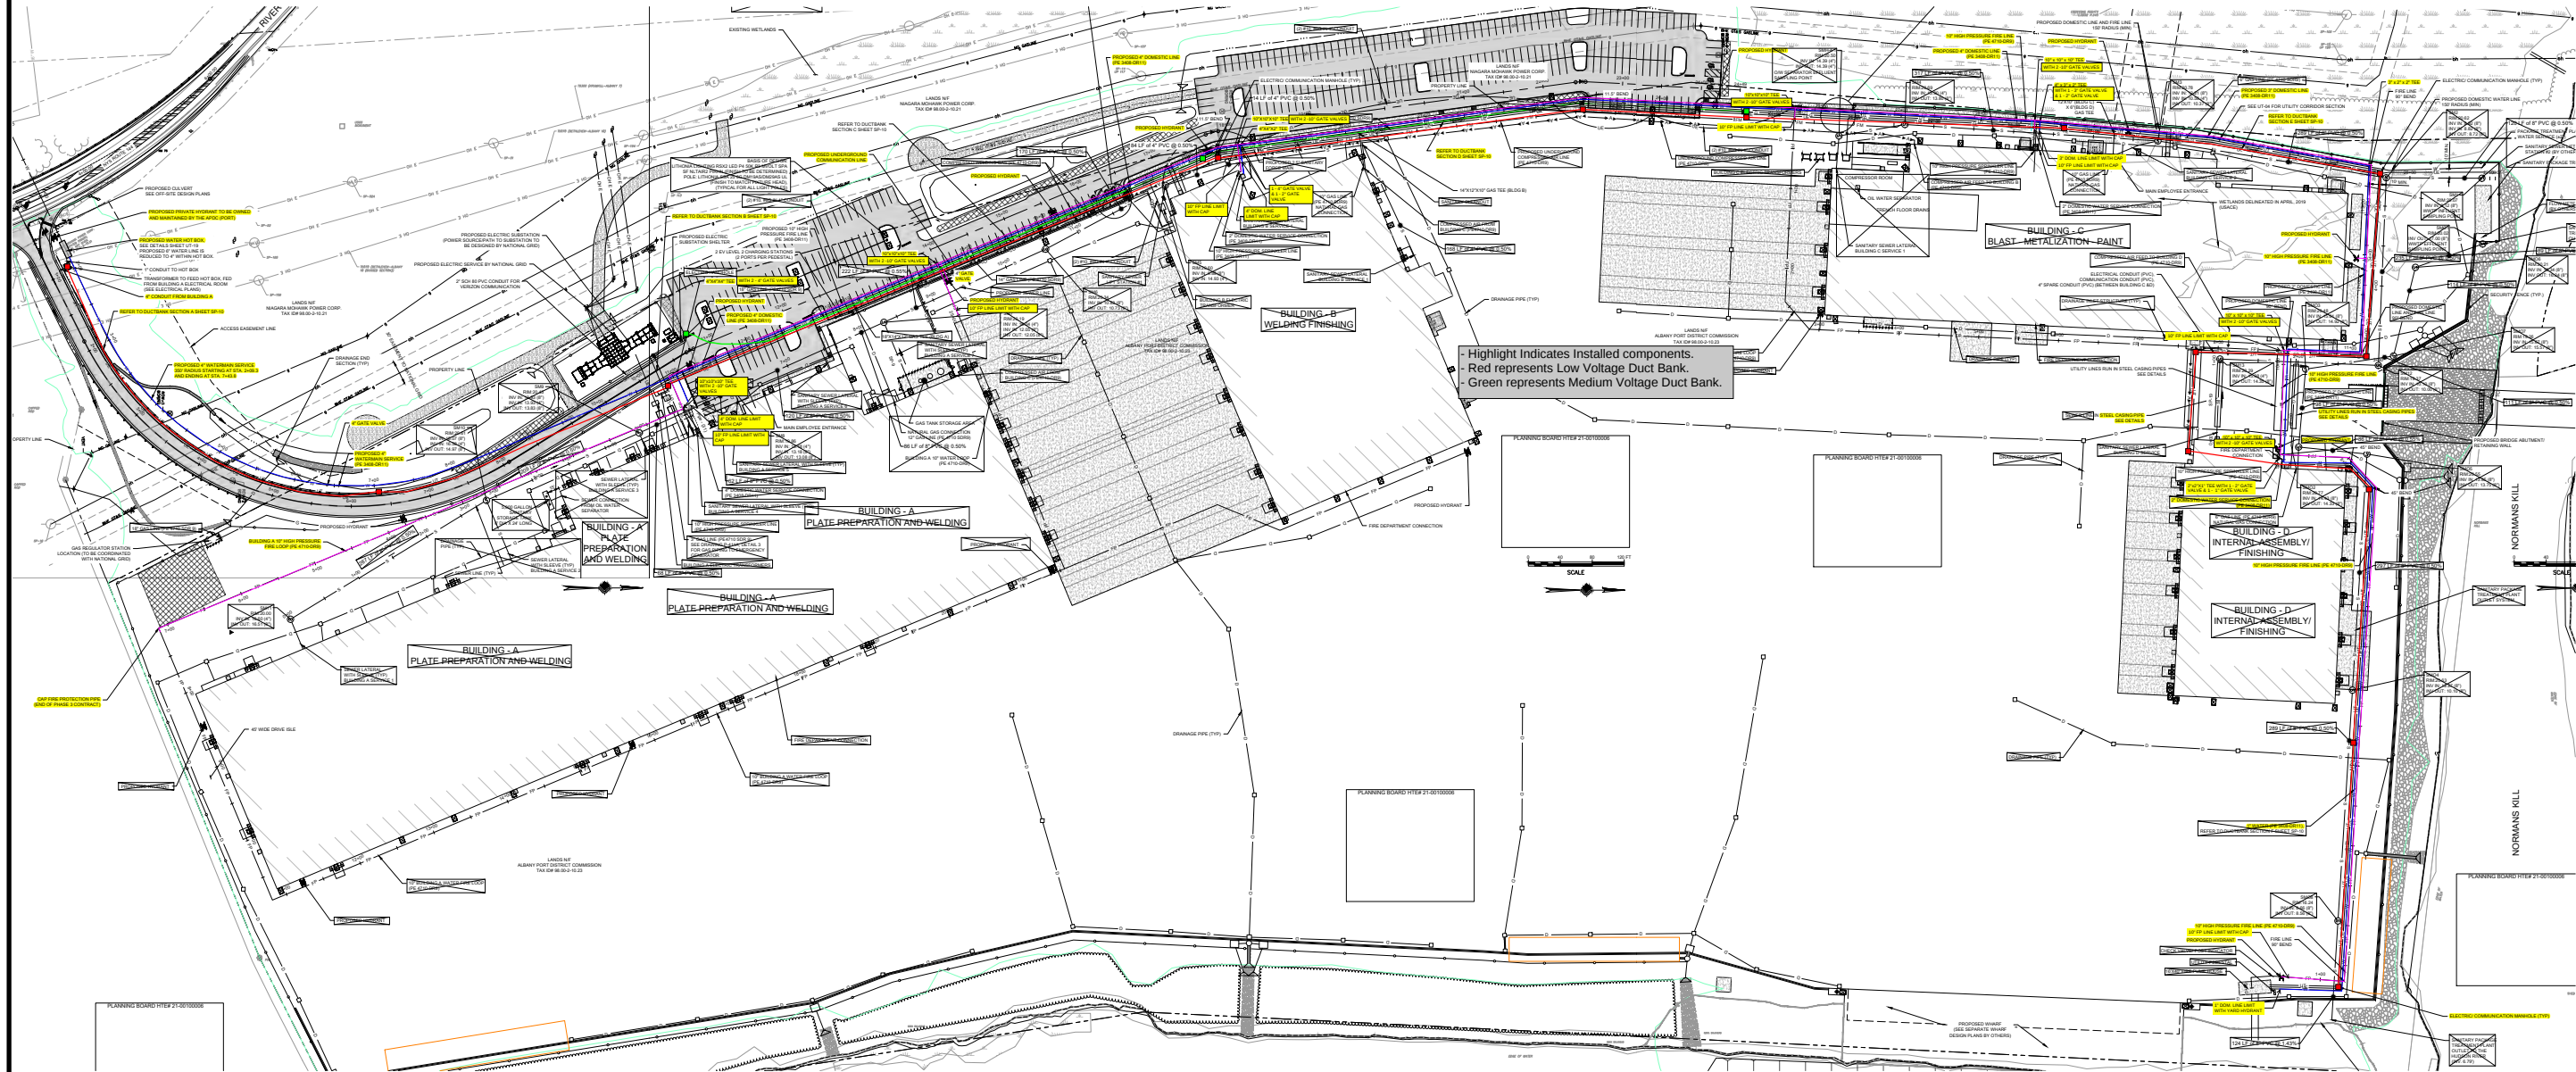
Utility As-Built Condition as of 11-01-2024

PROJECT: PoA - Expansion Project  
DATE: November 1, 2024  
DWG REF: UT-01 Through UT-06  
LOCATION: 340 River Rd, Glenmont, NY 12077

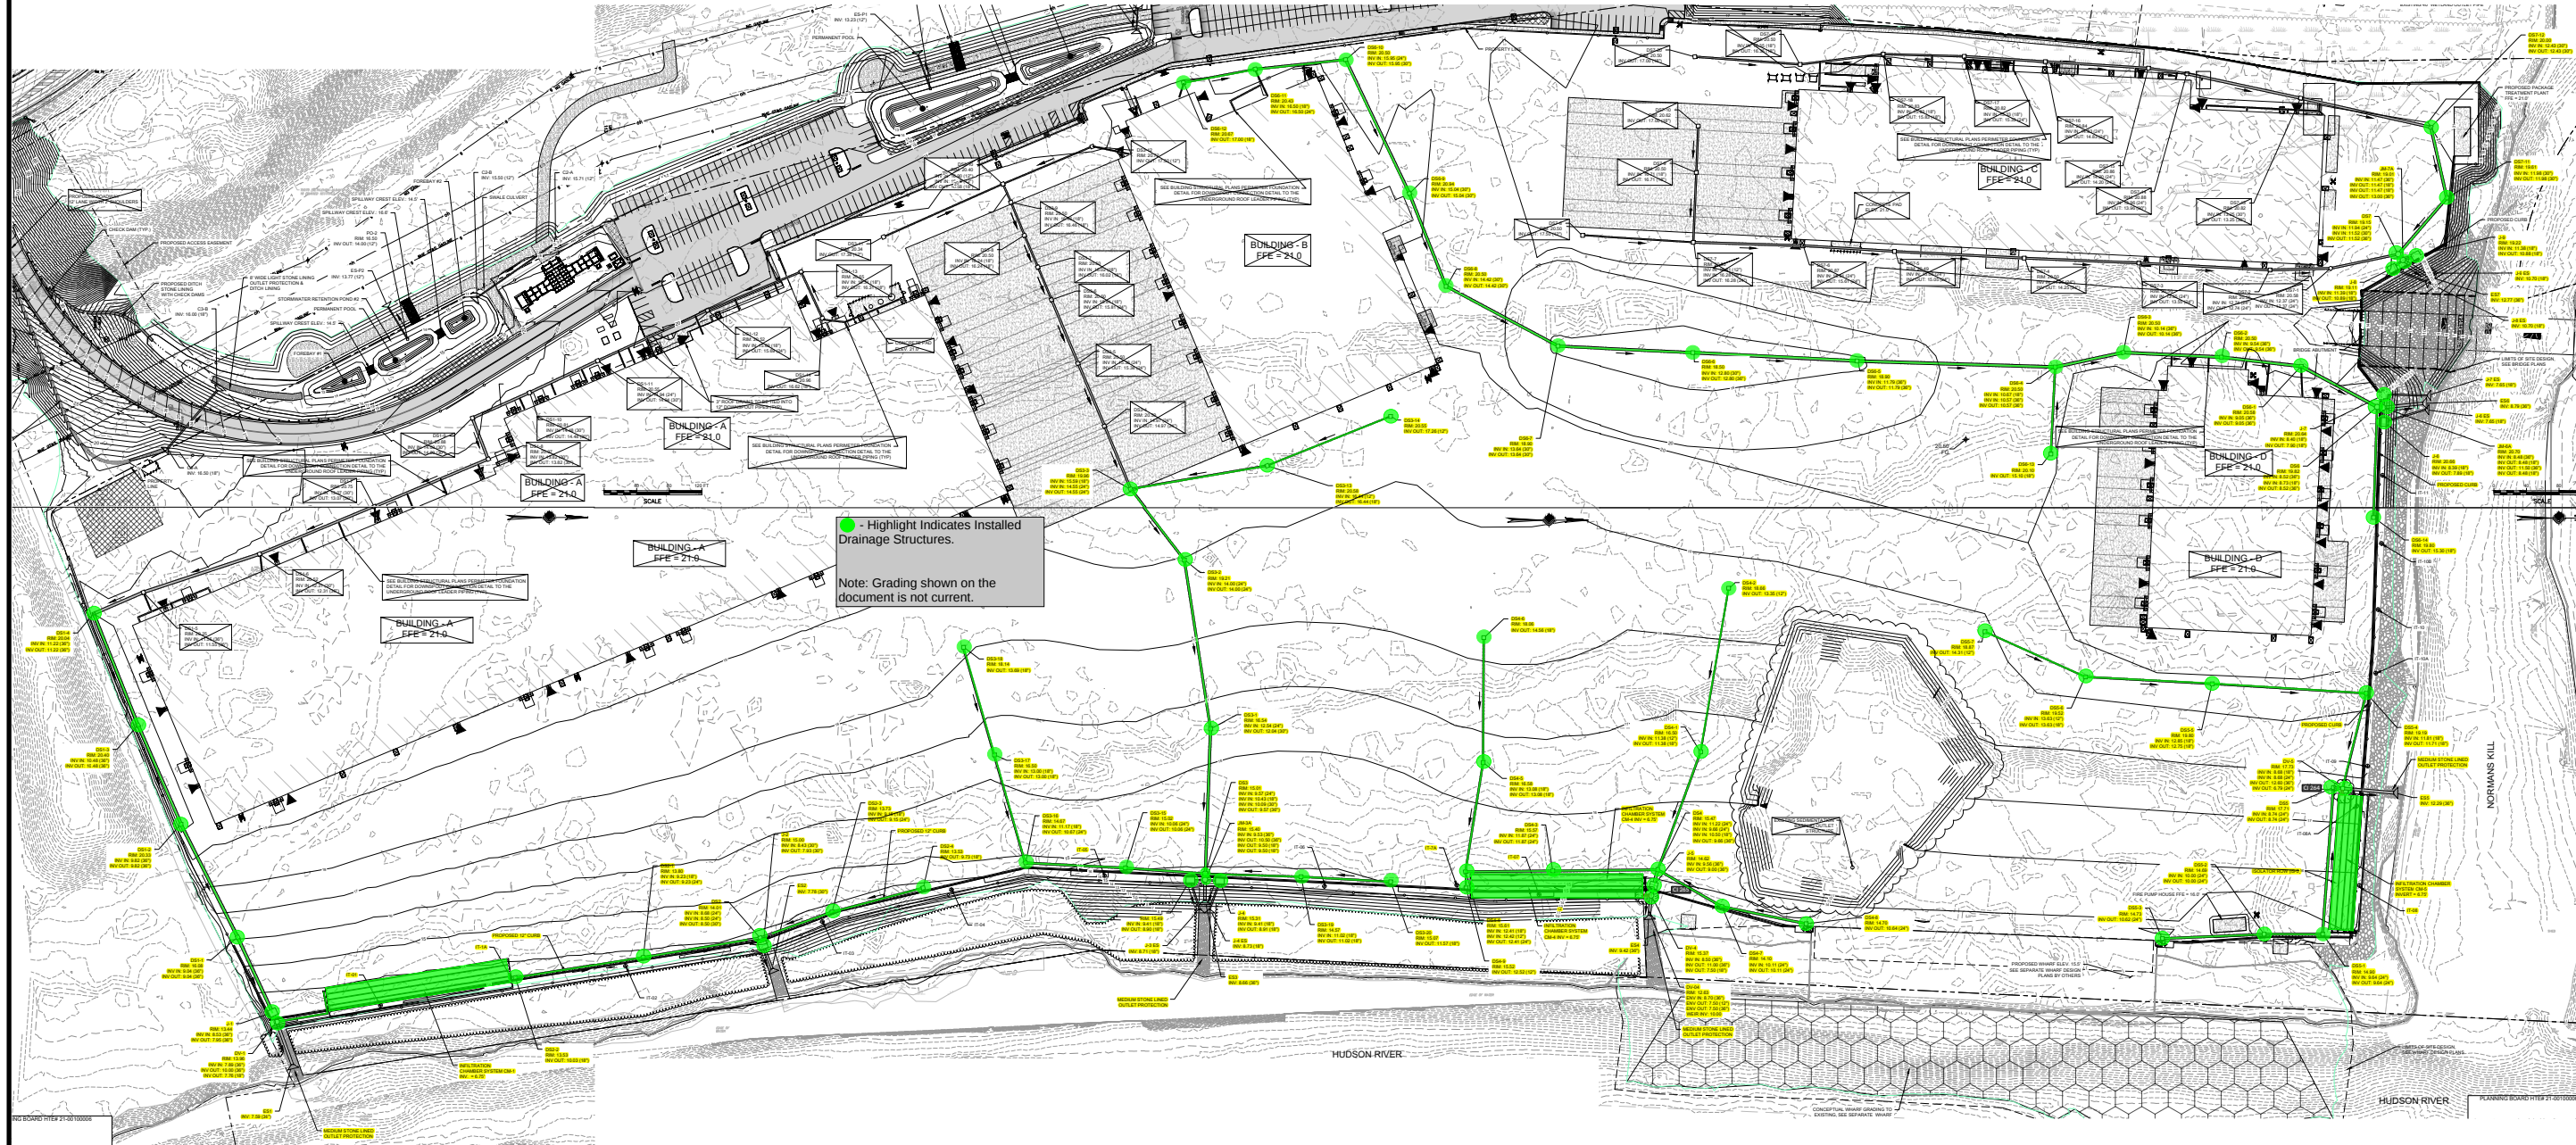
Drainage As-Built Condition as of 11-01-2024

PROJECT: PoA - Expansion Project  
DATE: November 01, 2024  
DWG REF: GR-01 Through GR-06  
LOCATION: 340 River Rd. Gelnmont, NY 12077
