## EXISTING CONDITIONS REFERENCE INFORMATION

### Summary of Port of Albany Field Investigation:

Project name:Port of Albany Wharf	
Project location:Albany	
Client:Port of Albany	Project code:14990
Preparer:MAS	Reviewer:
Report date:2025-04-02	Page number:1 of 48

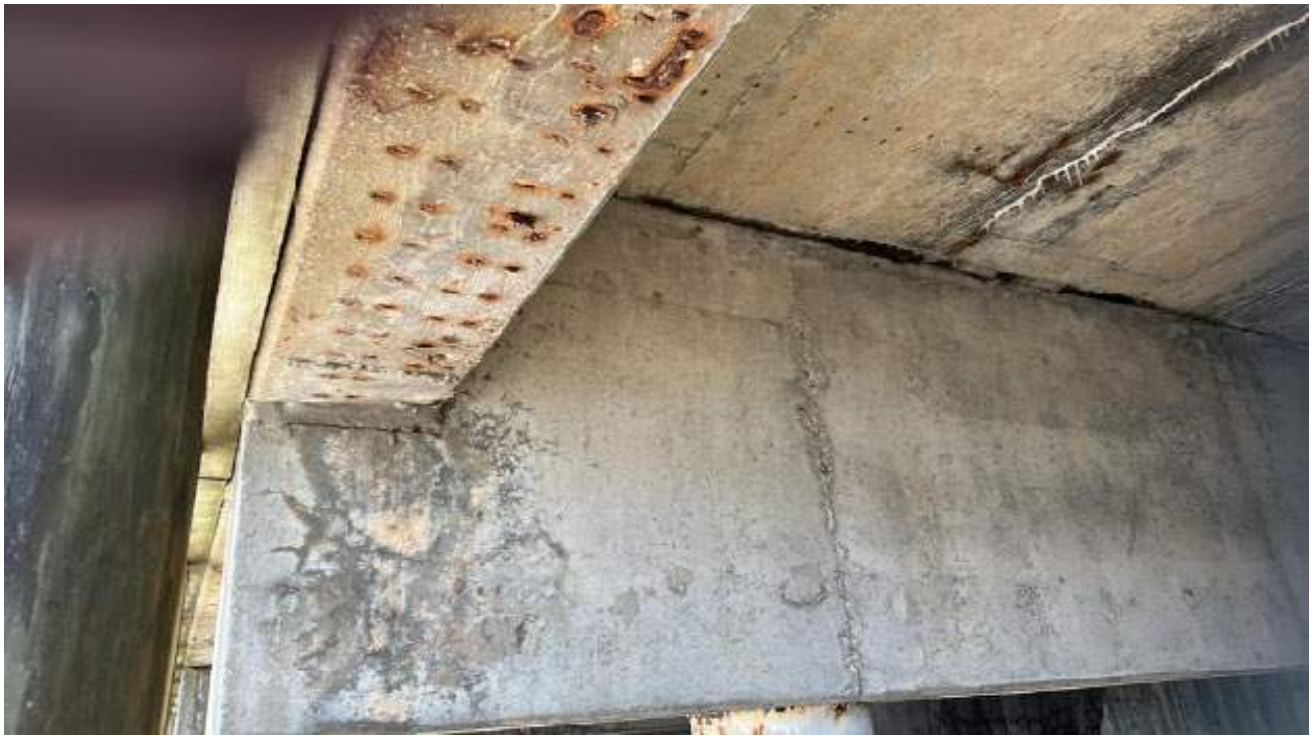
Media 24: Bent 12, P-12, Underside between Bents 12 and 13. Large crack at the bottom of bent 12.

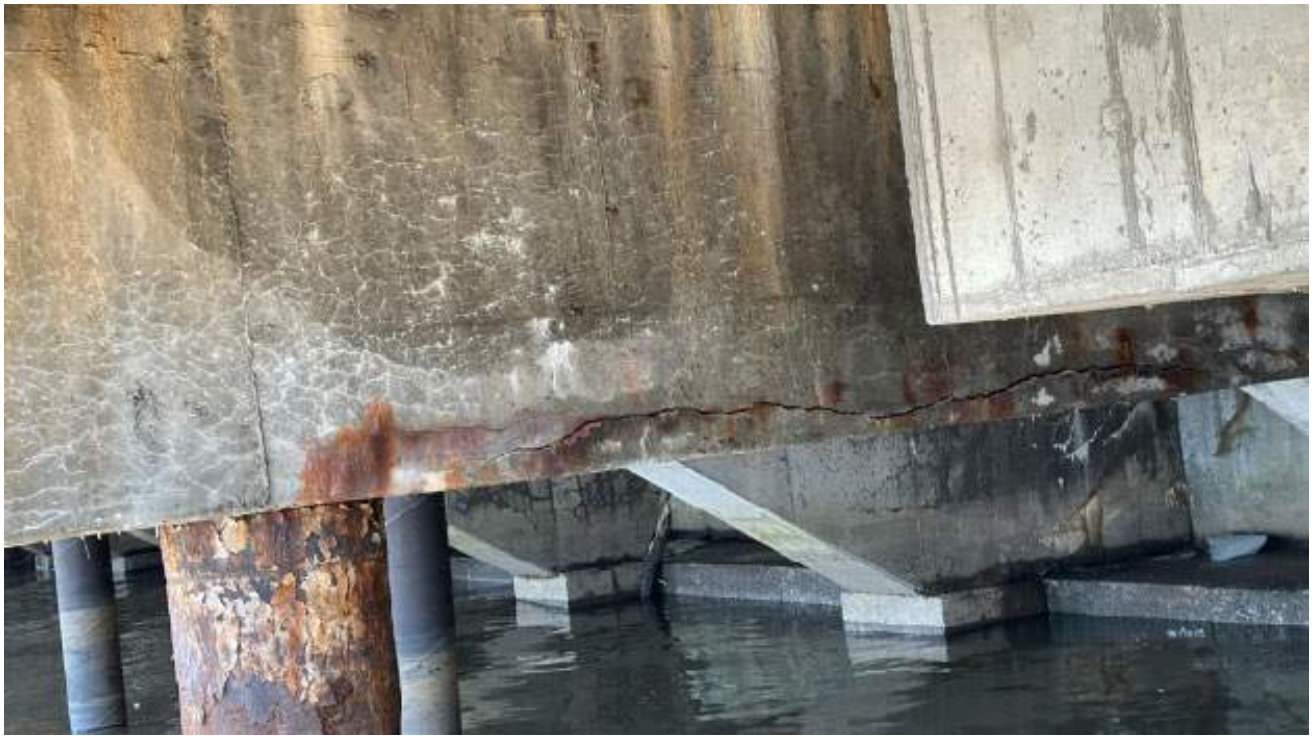
Tags:Deck	Taken by:Matthew Seinuk	Date taken:03/11/2025
Media 25: Bent 12, Underside between 12 and 13. Large crack at the bottom of bent 12.

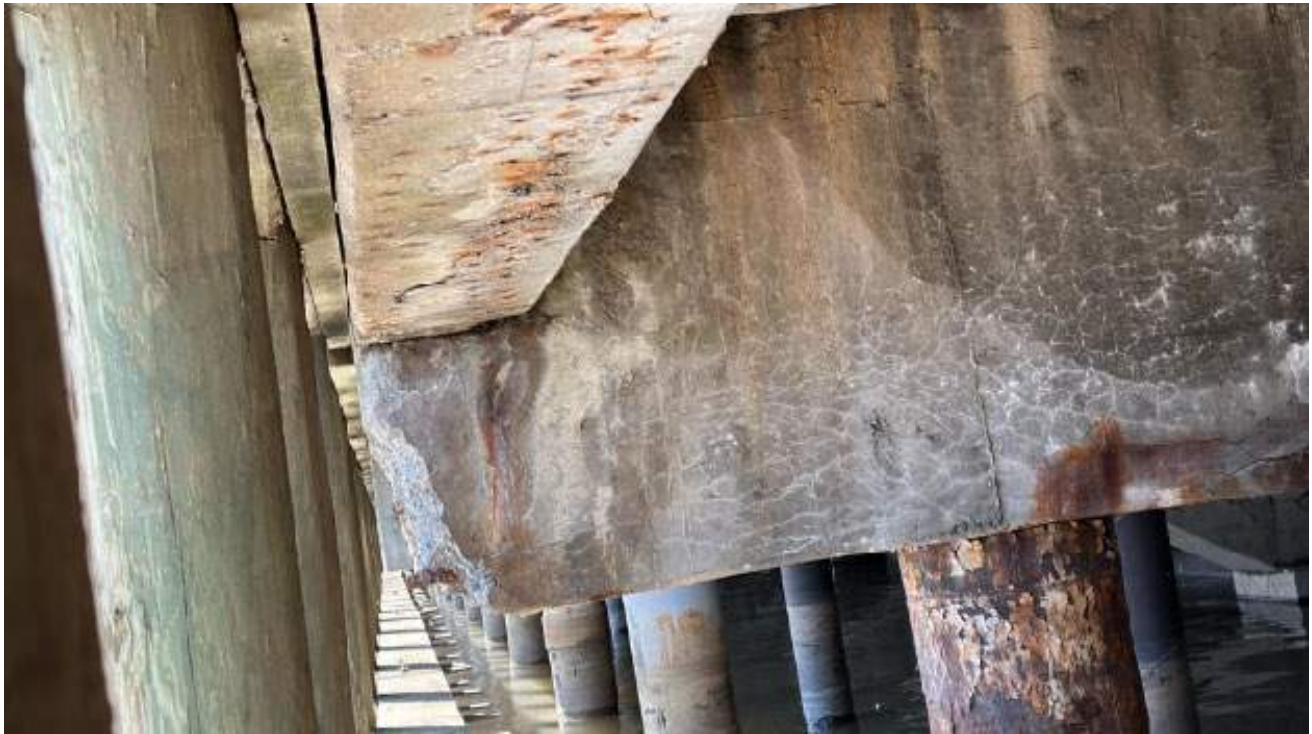
Tags:Deck	Taken by:Matthew Seinuk	Date taken:03/11/2025
Media 26: Bent 12, Underside between 12 and 13. Large crack at the bottom of bent 12.
