## EXISTING CONDITIONS REFERENCE INFORMATION

### Summary of Port of Albany Field Investigation:

# Fendering Photos

Project name:Port of Albany Wharf

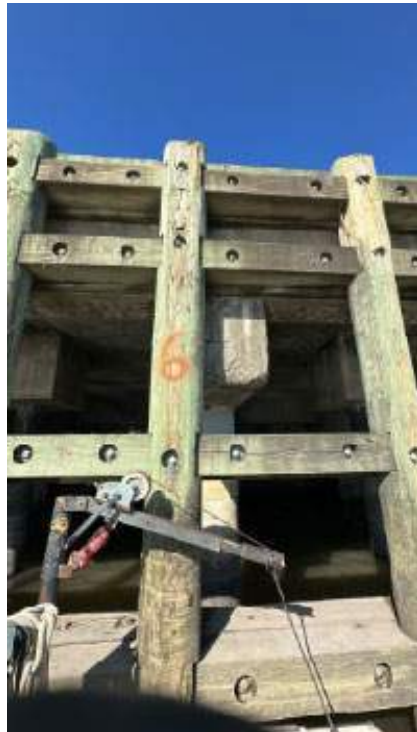
Media 12: Bent 6. Significant cracking on face of bent.

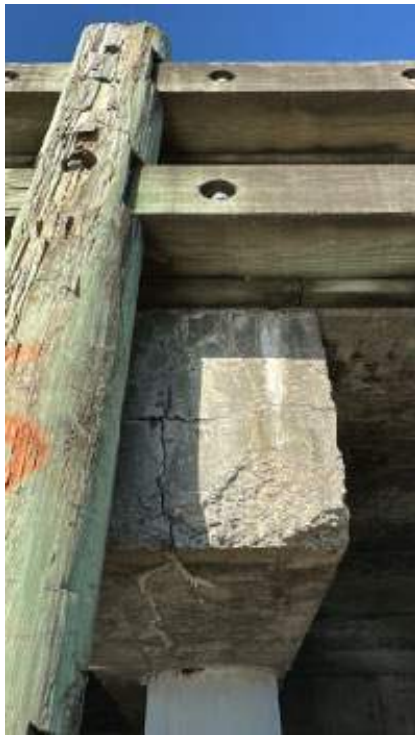
Media 13: Bent 6. Significant cracking on face of bent.

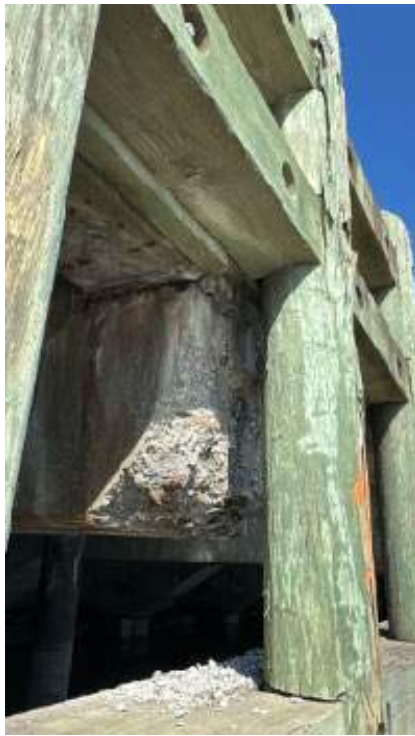
Media 29: Bent 12. Significant damage to face. Exposed rebar.

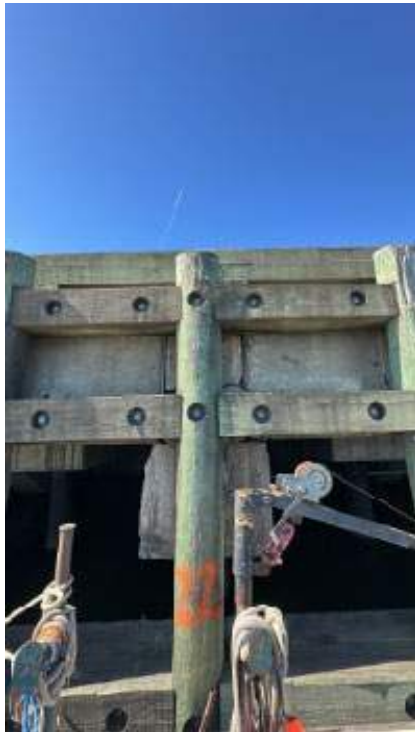
Media 61: Bent 22 expansion joint

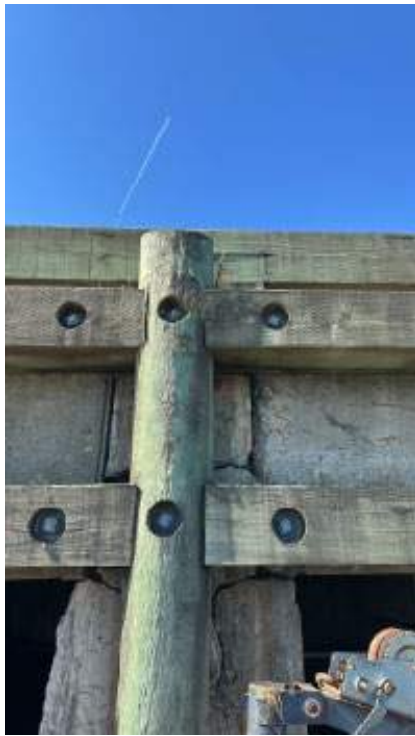
Media 63: Bent 22 expansion joint

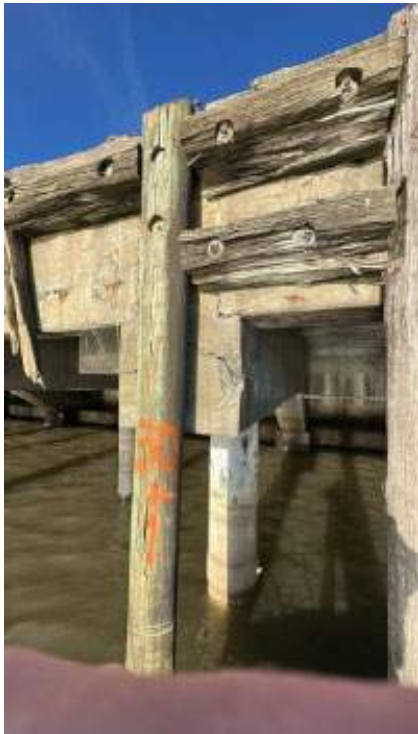
| Media 98: Bent 31. Note that after bent 30, every number is plus 1. | | |

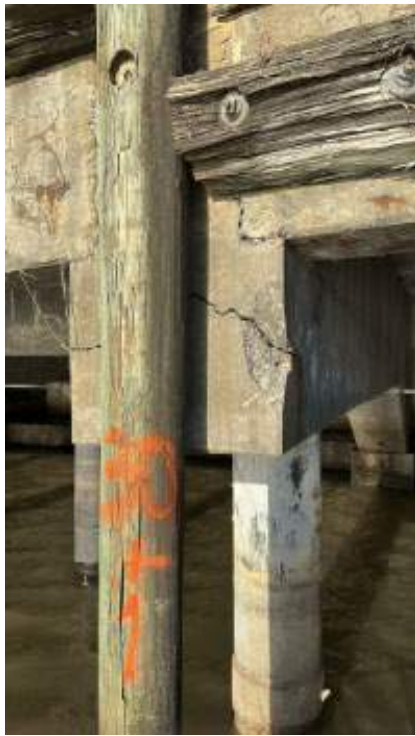
| Media 99: Bent 31. Note that after bent 30, every number is plus 1. | | |

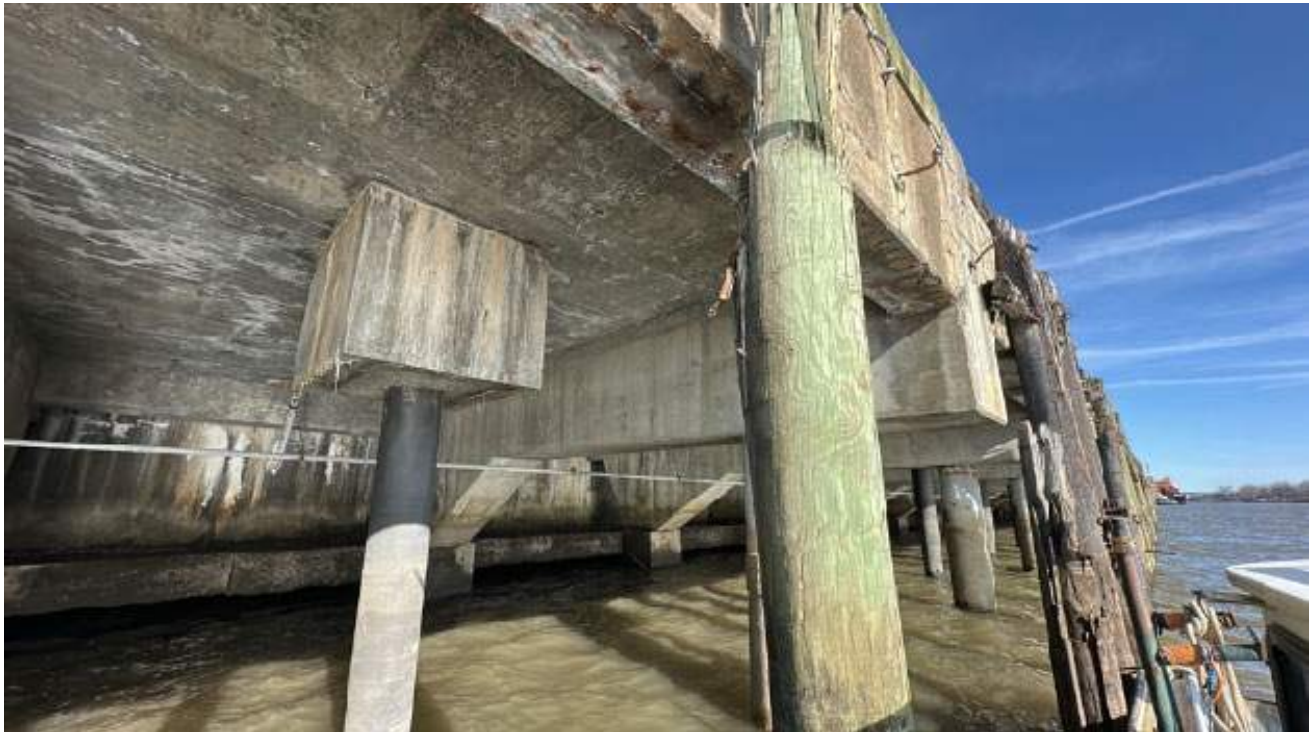
Media 114: Bent 35, P-35, Underside between bents 35 and 36.

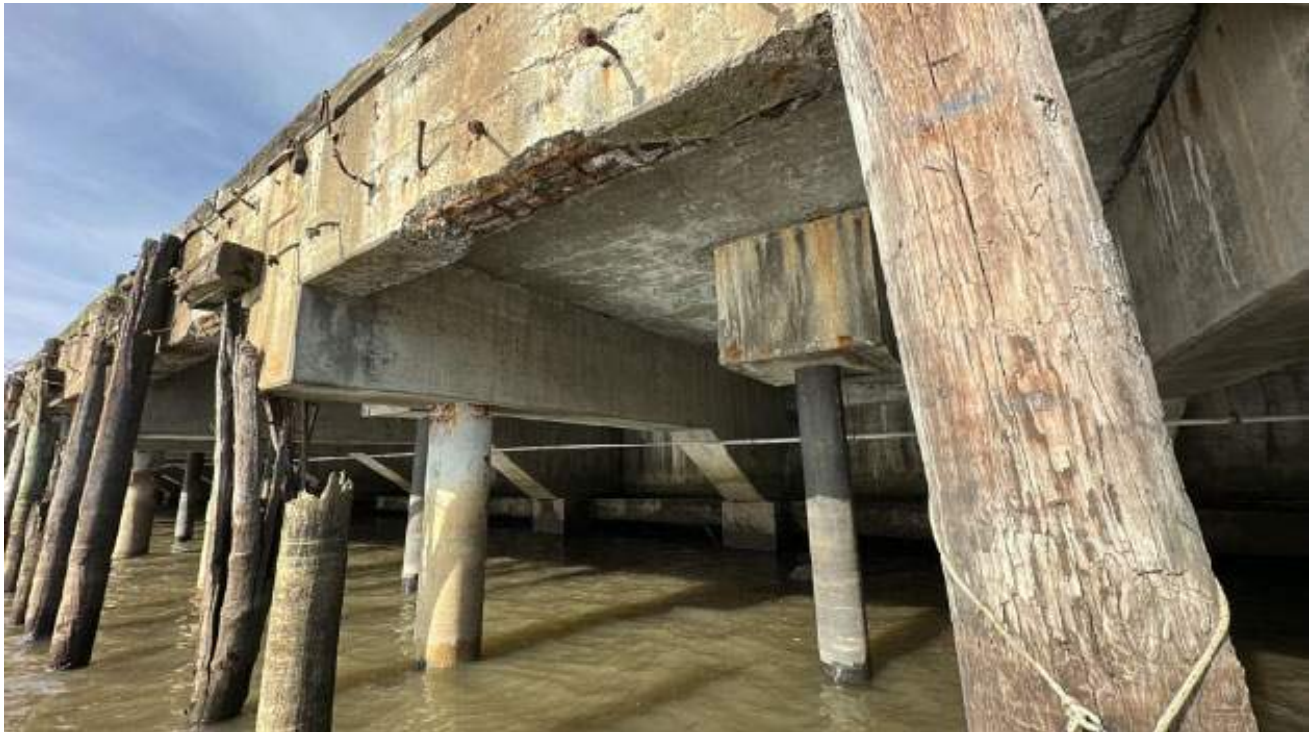
Media 120: Bent 37, Underside between bent 37 and 38.

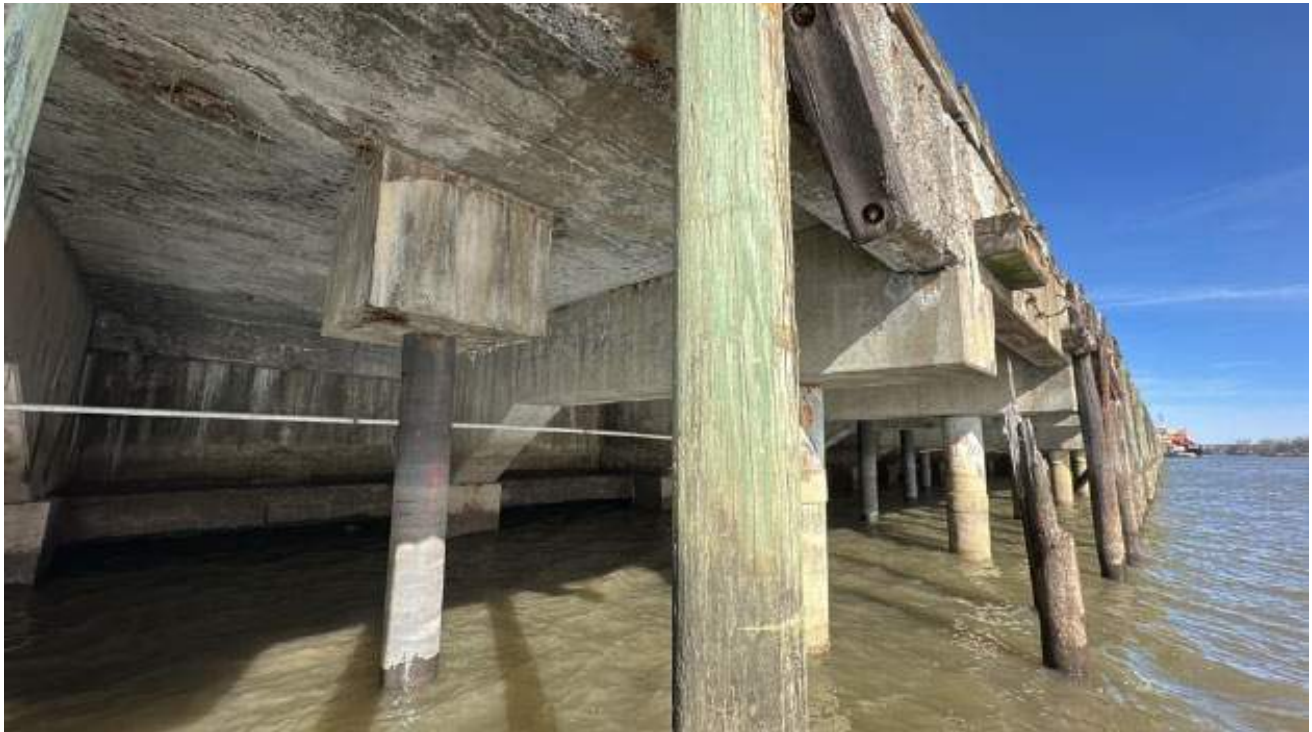
Media 136: Bent 40, P-40, Underside between bents 40 and 41.

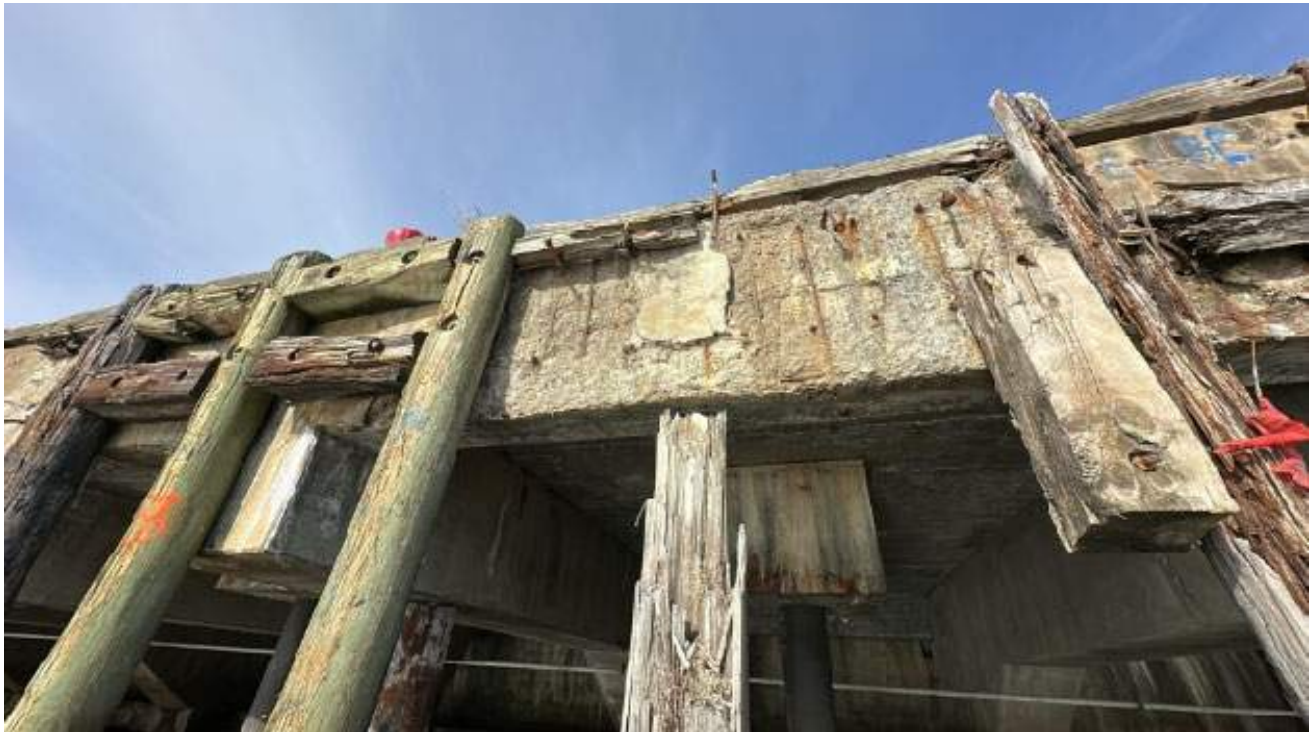
Media 222: Complete loss of cover between fence 38 and 39 on fascia beam.

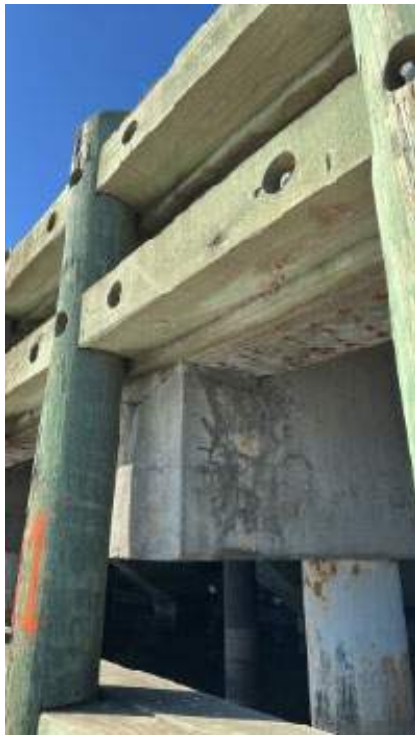
Media 229: Cracking on Bent 11.

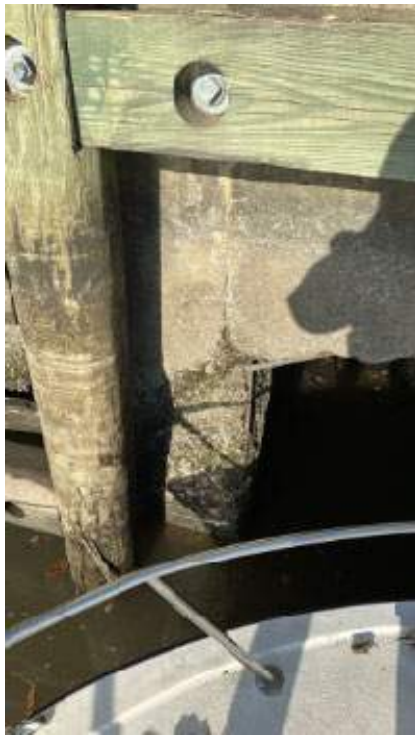
Media 231: Damage at bottom of bent one.

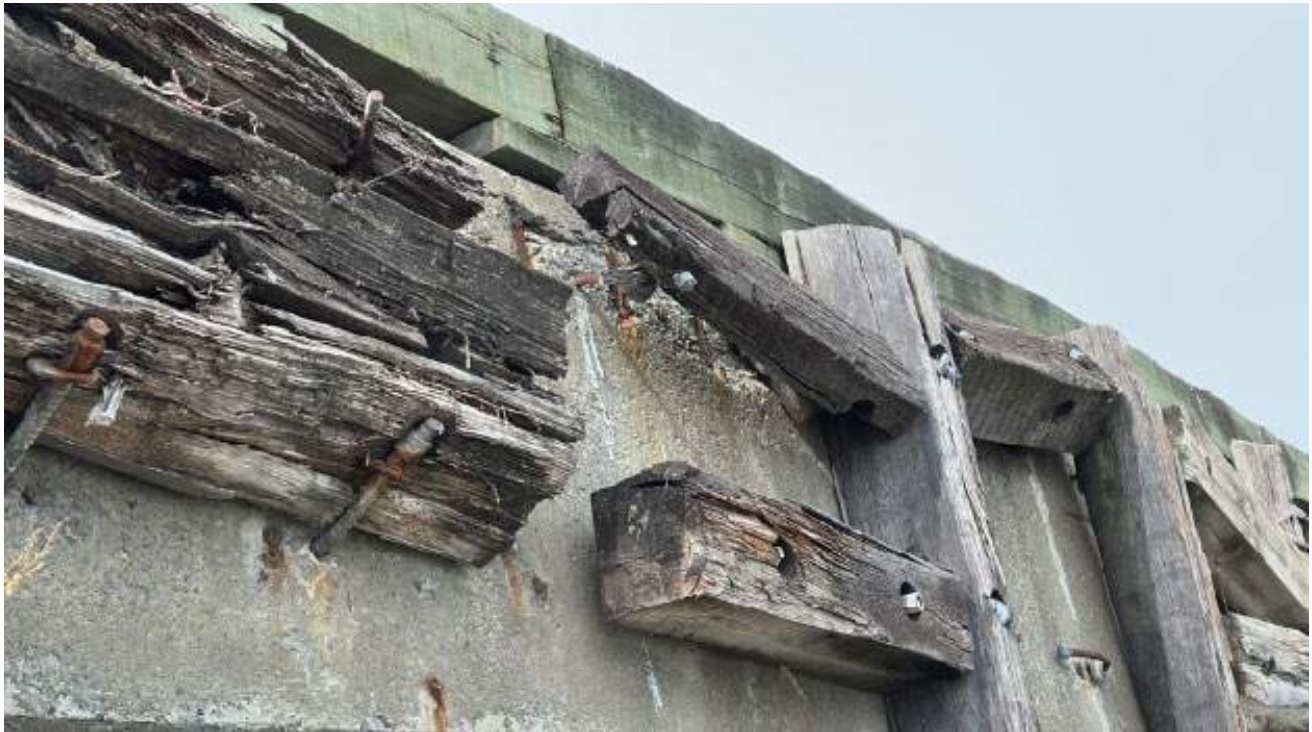
Media 236: Exposed rebar on fascia beam between bent 52 and 53

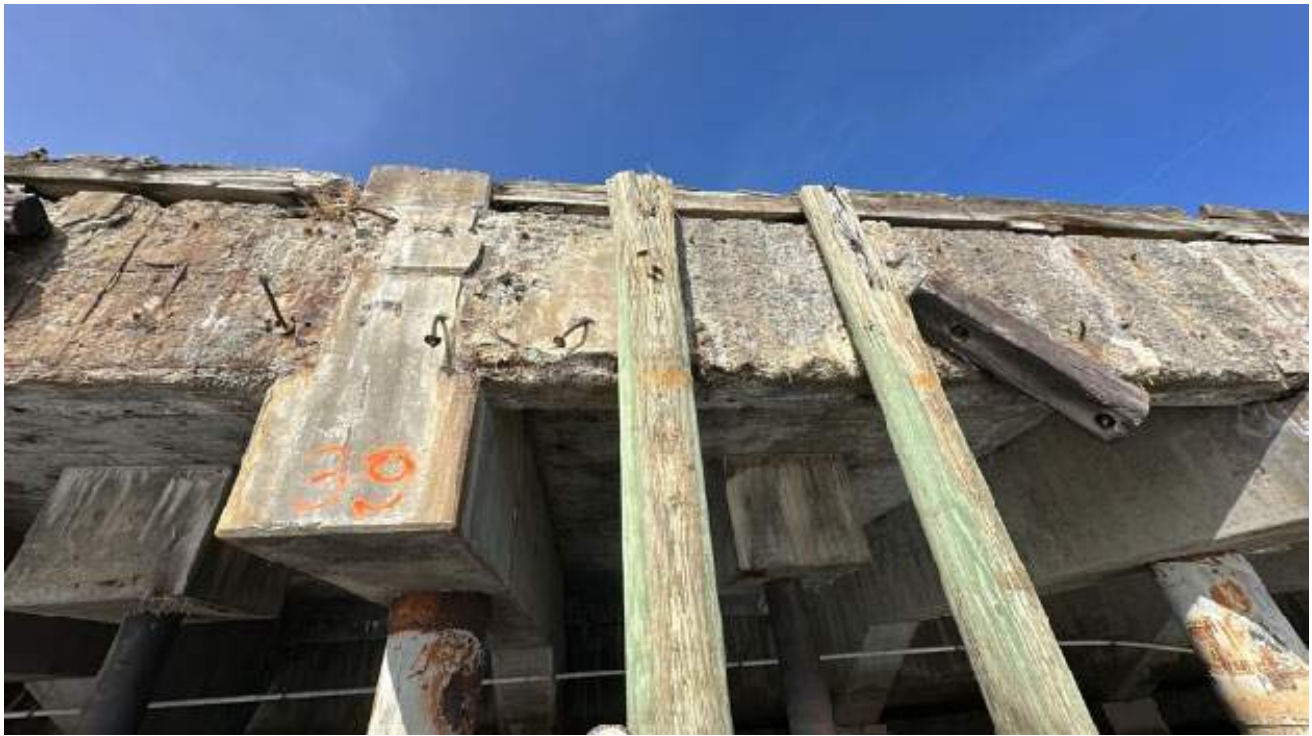
Media 241: Significant scour on fascia beam between bent 40 and 41.

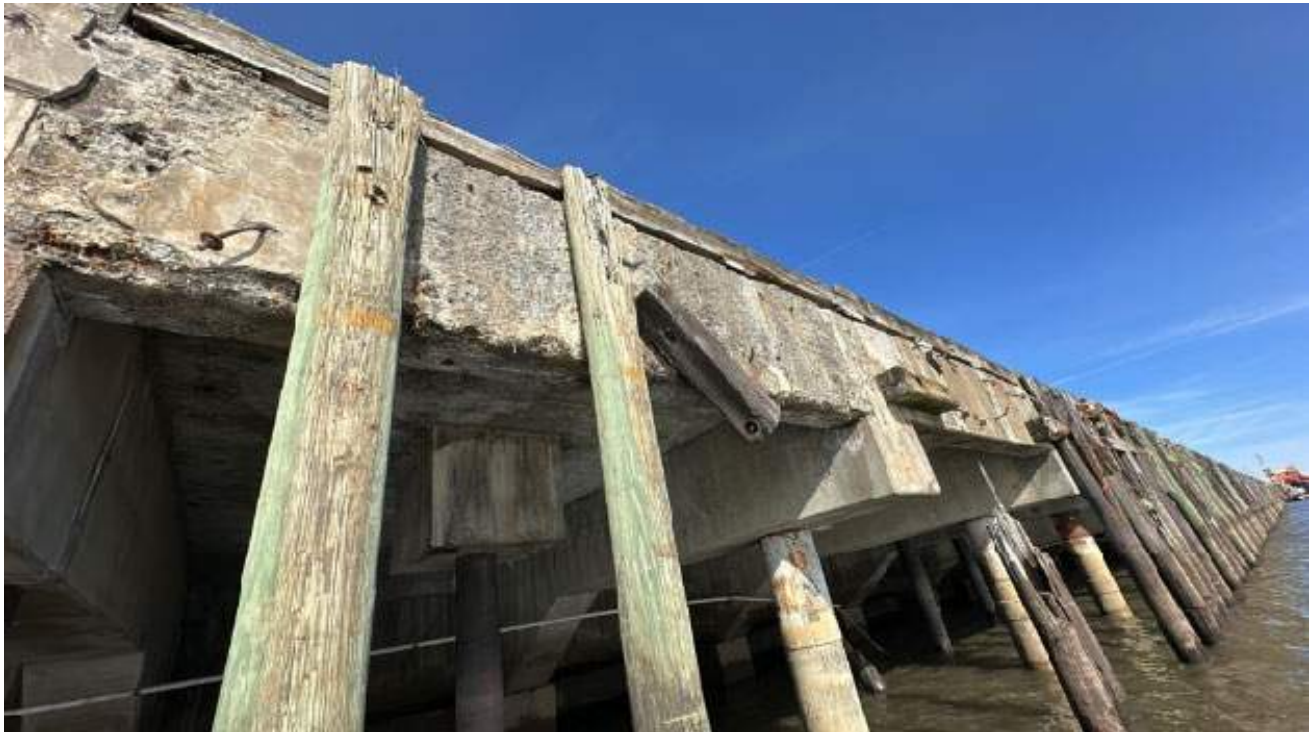
Media 242: Significant scour on fascia beam between bent 40 and 41.
